**REPORT OF THE INVESTIGATION
INTO THE
TANK SHIP MTM DUBLIN (IMO NO. 9335824)
CREWMEMBER LOSS OF LIFE IN MASSACHUSETTS
BAY, APPROXIMATELY 6 NMI EAST OF NAHANT, MA
ON SEPTEMBER 26, 2023**

MISLE ACTIVITY NUMBER: 7798704

INVESTIGATING OFFICER'S REPORT

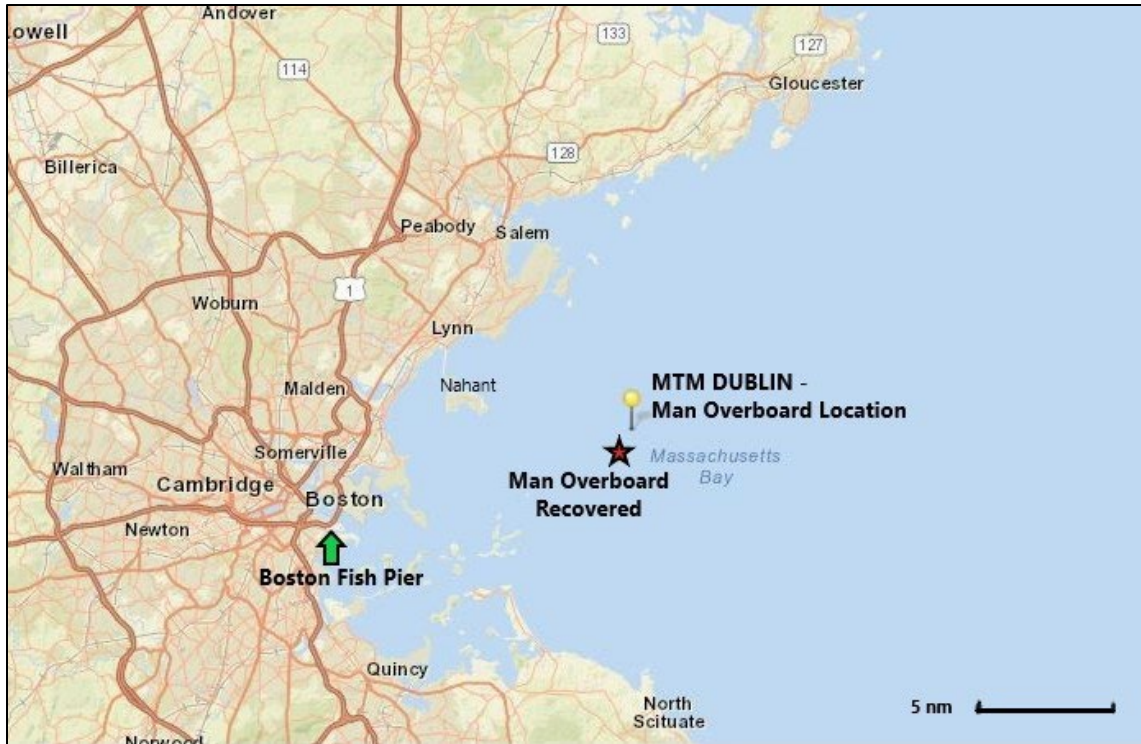
Figure 2. Locations where AB went overboard, was recovered from the water, and transferred to ambulance on shore (Source: USCG).

4.1.16. At 0437, the master of the MTM DUBLIN transmitted a mayday on channel 16 for the man overboard in position 42° 24.3' N, 070° 46.9' W (Figure 2). The vessel's digital selective calling alert was also activated on the bridge.

4.1.31. At 0531, the crew on the AMERICA spotted the man overboard face down in the water and unconscious, in position 42° 23.440' N 070° 47.250' W (Figure 2). They immediately began attempting to recover him.

4.1.36. At 0722, the AMERICA arrived at Boston Fish Pier (Figure 2) where the AB was transferred to an ambulance and transported to Massachusetts General Hospital. The ambulance reported the AB was still unresponsive with no pulse detected.
