REPORT OF THE INVESTIGATION INTO THE PASSENGER VESSEL SANDY GROUND (O.N. 1299657) ENGINE ROOM FIRE IN UPPER NEW YORK BAY ON DECEMBER 22, 2022

**ENGINE ROOM FIRE ONBOARD THE PASSENGER FERRY SANDY GROUND
(O.N. 1299657) IN THE BAY RIDGE CHANNEL NEAR MANHATTAN, NEW YORK
ON DECEMBER 22, 2022**

INVESTIGATING OFFICER'S REPORT

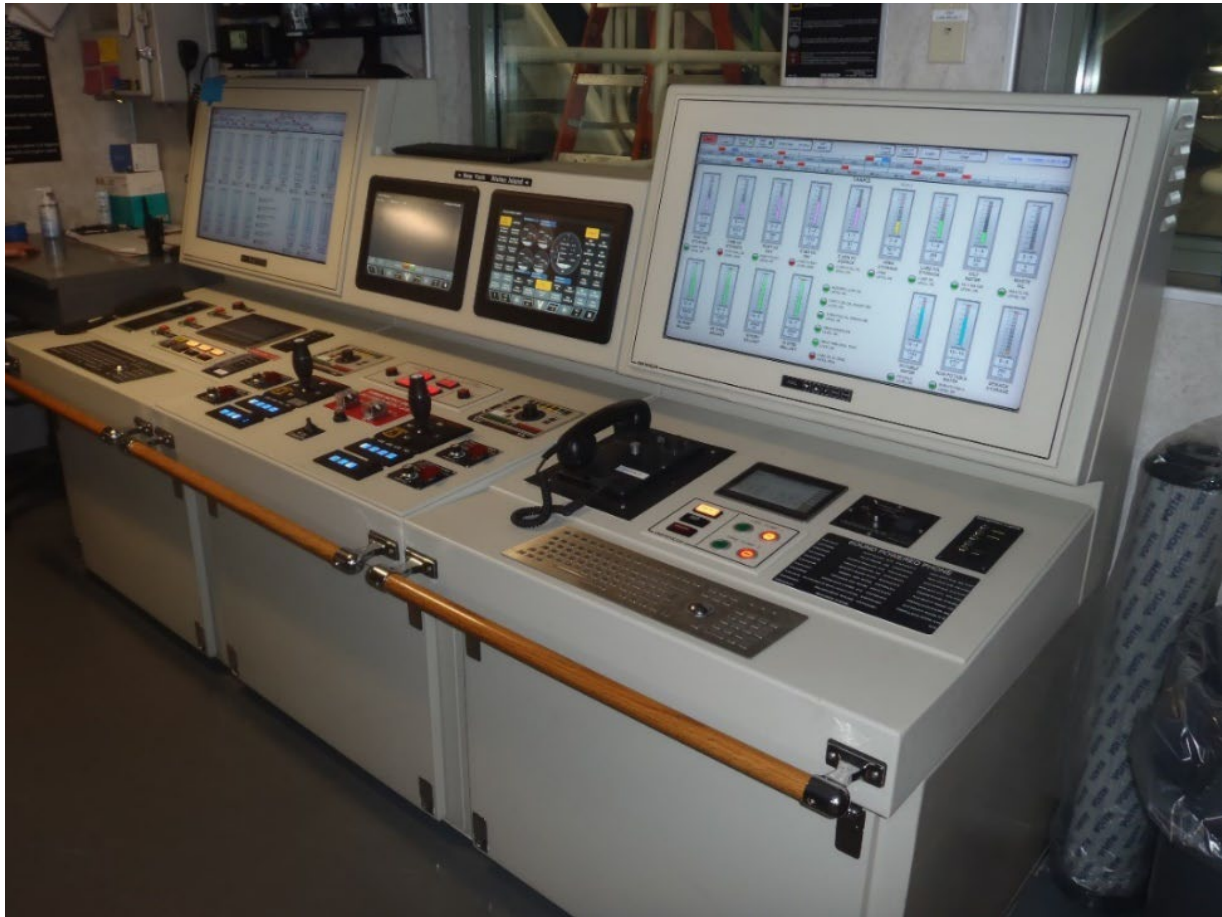
Figure 2. Photograph of the Machinery Control Station (MCS) in the Engine Operating Station (EOS) with the tank level indication display onboard the SANDY GROUND's sister vessel, the SSG MICHAEL H OLLIS, taken on December 23, 2022. Provided by the U.S. Coast Guard.

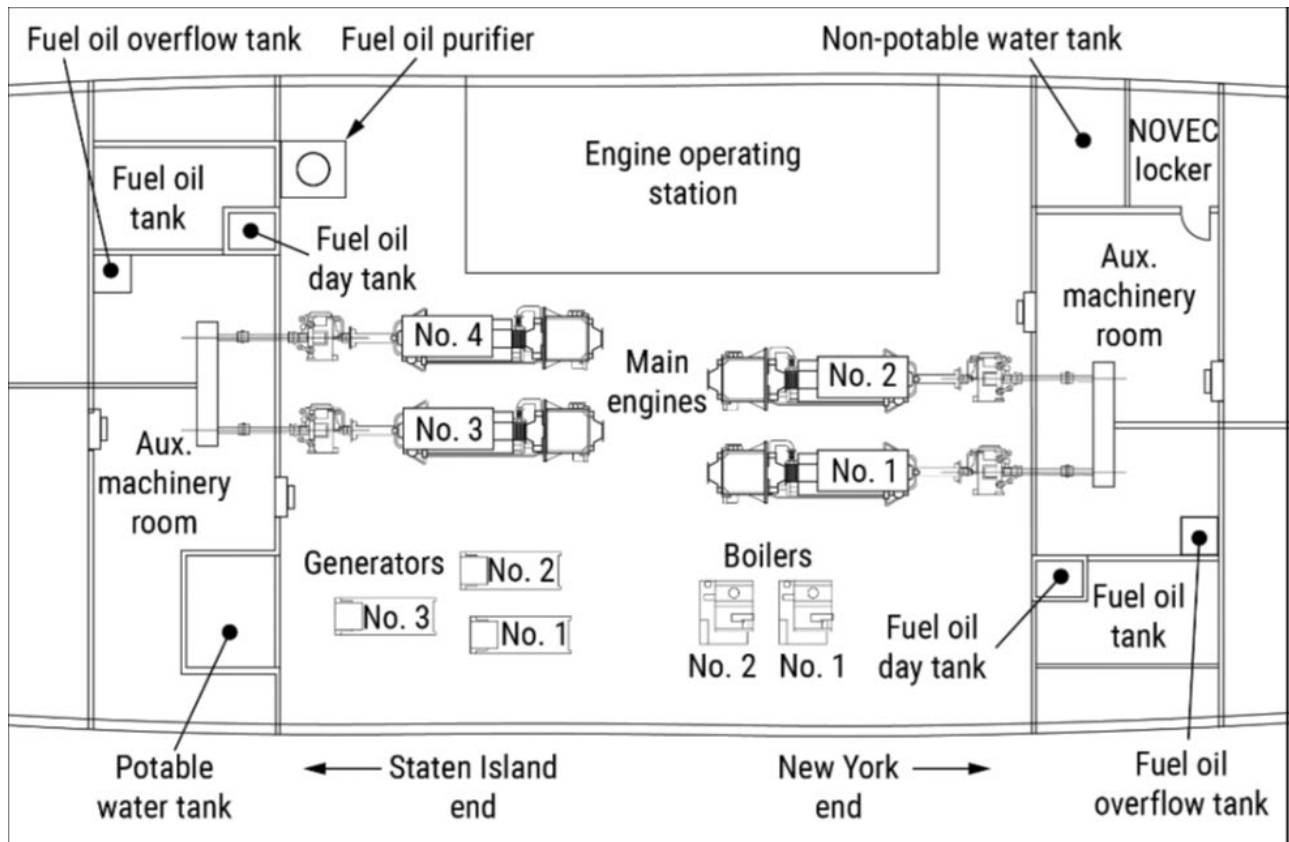
Figure 4. SANDY GROUND Engine Room Layout. Provided by the NYC DOT Staten Island Ferry Division and annotated by the NTSB.

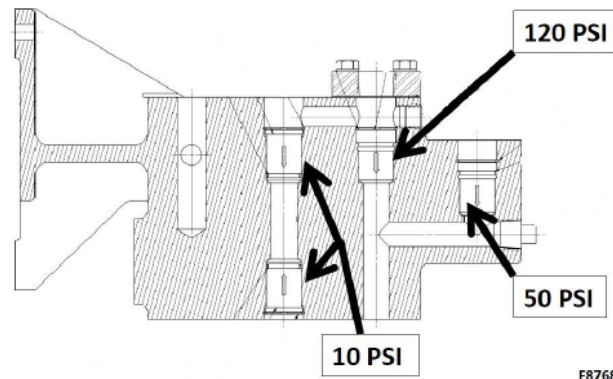
Figure 7-8: Fuel Manifold/Block and Check/Relief Valves

Contained within the fuel manifold/block are four check/relief valves.

The two 10 psi check valves serve as shuttle valves and allow the higher pressure of fuel pump outlet or engine prime pump to go through the fuel filters and then to the injector supply loop.
