REPORT OF THE INVESTIGATION INTO THE ILLEGAL SMALL PASSENGER VESSEL STIMULUS MONEY (NJ 8563HN), CAPSIZING WITH LOSS OF LIFE ON JULY 12, 2022

**CAPSIZING OF THE MOTOR VESSEL STIMULUS MONEY RESULTING IN
THE LOSS OF TWO LIVES WHILE OPERATING ON THE HUDSON RIVER
IN THE VICINITY OF INTREPID PIER 90, MANHATTAN, NEW YORK
ON JULY 12, 2022**

ILLEGAL SMALL PASSENGER VESSEL STIMULUS MONEY (NJ 8563HN), CAPSIZING WITH LOSS OF LIFE ON JULY 12, 2022

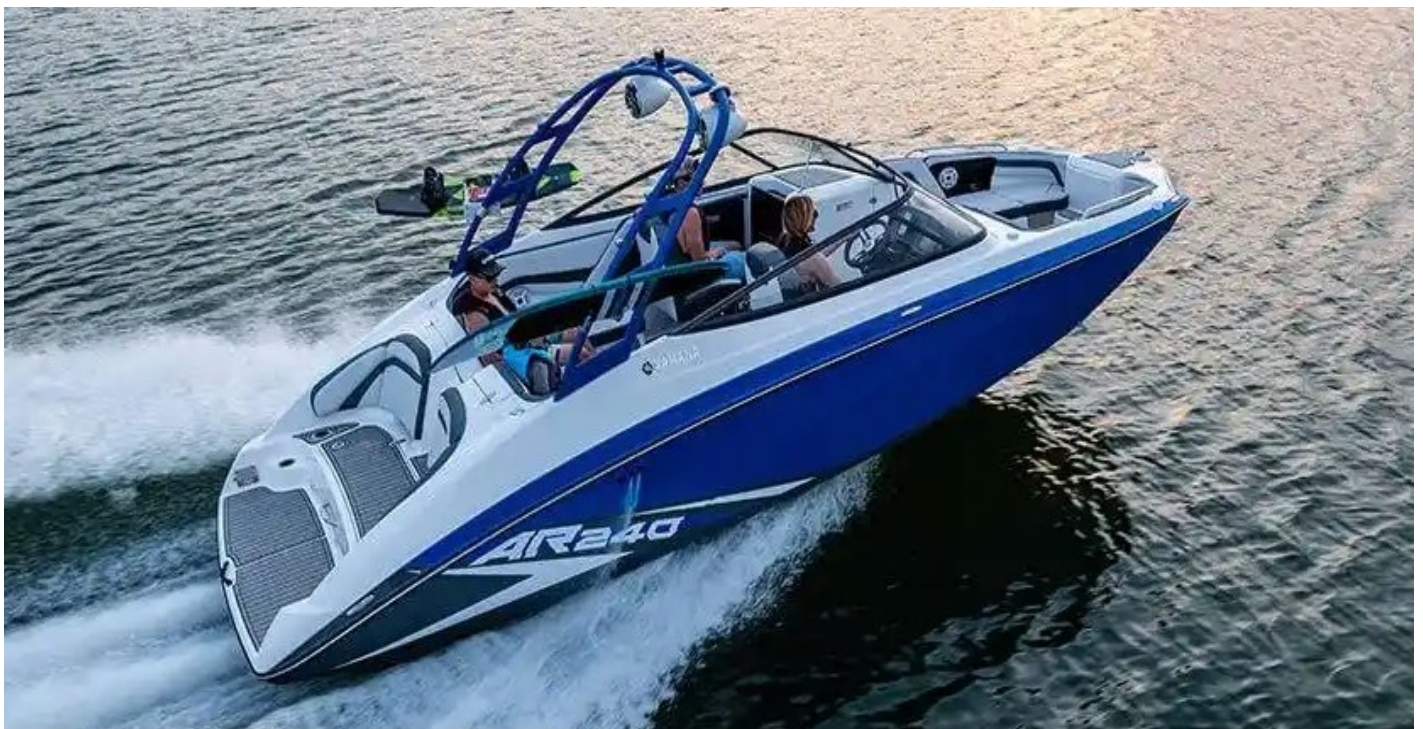
The passengers were unevenly distributed throughout the vessel (fig. 6), in contrast with manufacturer's direction outlined in (fig. 8) about even weight distribution. (fig. 7) depicts even weight distribution and the vessel being operated beneath maximum capacity.

Figure 7. Stock photograph of Yamaha AR240 with a total of 4 persons onboard, showing limited spacing for comparison of STIMULUS MONEY 13 person count, courtesy of Google Images.
