MARINE CASUALTY REPORT

**MOBILE OFFSHORE DRILLING
UNIT (MODU) OCEAN RANGER,
O.N. 615641,
CAPSIZING AND SINKING
IN THE ATLANTIC OCEAN,
ON 15 FEBRUARY 1982
WITH MULTIPLE LOSS OF LIFE**

REPORT NO. USCG 16732/0001 HQS 82

1. Report No. USCG 0001 HQS 82	2. Government Accession No.	3. Recipient's Catalog No.	
4. Title and Subtitle Marine Casualty Report Mobile Offshore Drilling Unit (MODU) OCEAN RANGER, O.N. 615641, Capsizing and Sinking in the Atlantic Ocean on 15 February 1982 with multiple loss of life		5. Report Date 20 May 1983	6. Performing Organization Code G-MMI-1/HQ14

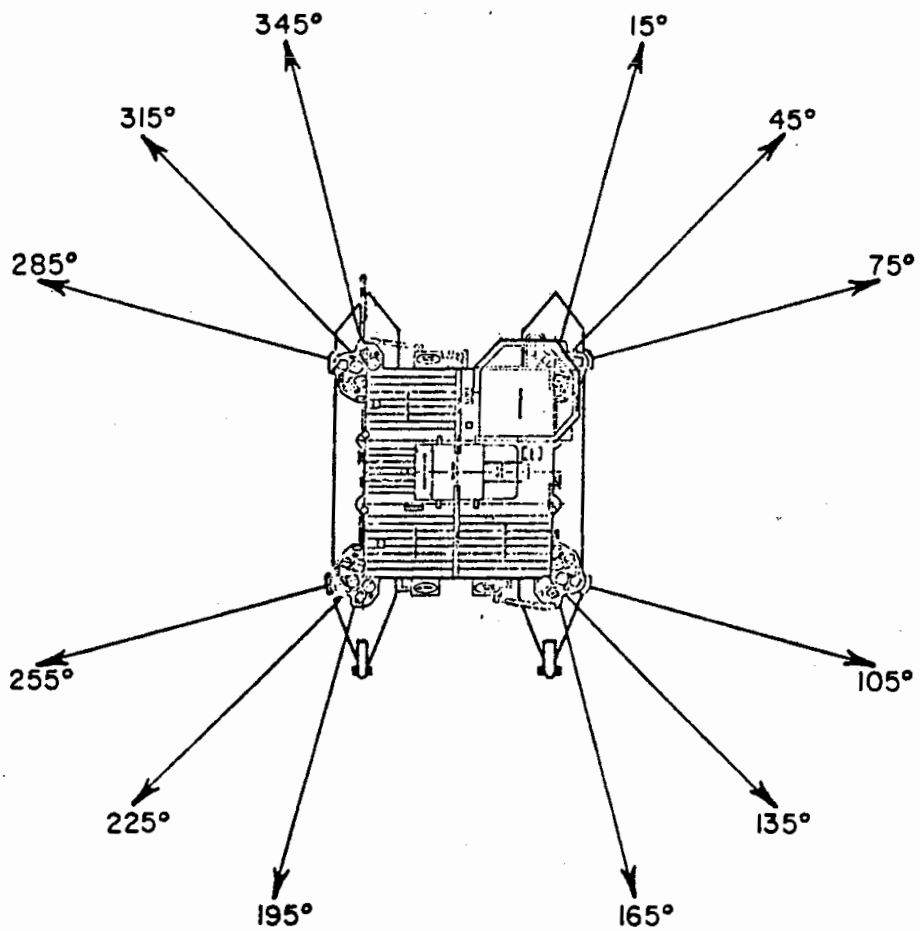
The OCEAN RANGER was maintained in position at a drilling site by means of a 12 point, spread mooring system, consisting of 12-45,000 lb. anchors, ranged three each from the four corner columns: PC-1, PC-4, SC-1, and SC-4 (please see figure 4 on page 9). Each anchor was attached to 1600 ft of 3 1/4 inch link chain, which in turn was connected to 4500 ft of 3 1/2 inch wire rope. The anchor chains were stored in chain lockers in the corner columns, and ranged through individual chain pipe openings at the tops of the columns, each measuring approximately 6 sq ft. The connecting wire ropes were stored on drums located atop the columns, and were led down into the chain lockers through individual wire trunk openings at the tops of the columns, each measuring approximately 25 sq ft, to lower sheaves and out through the chain pipes (please see figure 5 on page 10). Each chain/wire rope was then led through hawse pipes, down the side of the column to a fairlead sheave, and away from the rig to the deployed anchor. Control of the chain/wire ropes was maintained through 12 winch-windlass units mounted atop the corner columns, each of which had a stall pull equal to half the breaking strength of the mooring lines, and a brake capacity exceeding the breaking strength of the mooring lines. The breaking strength of the wire rope was approximately 1,200,000 lbs. Remote read-out devices located in the Ballast Control Room (inoperative at the time of the casualty) and in

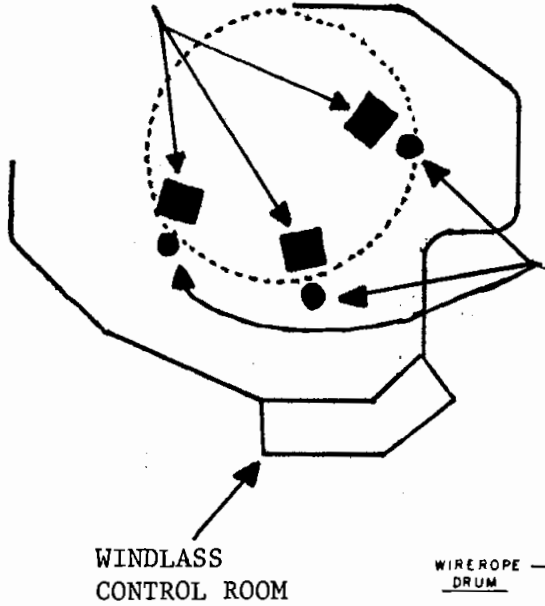
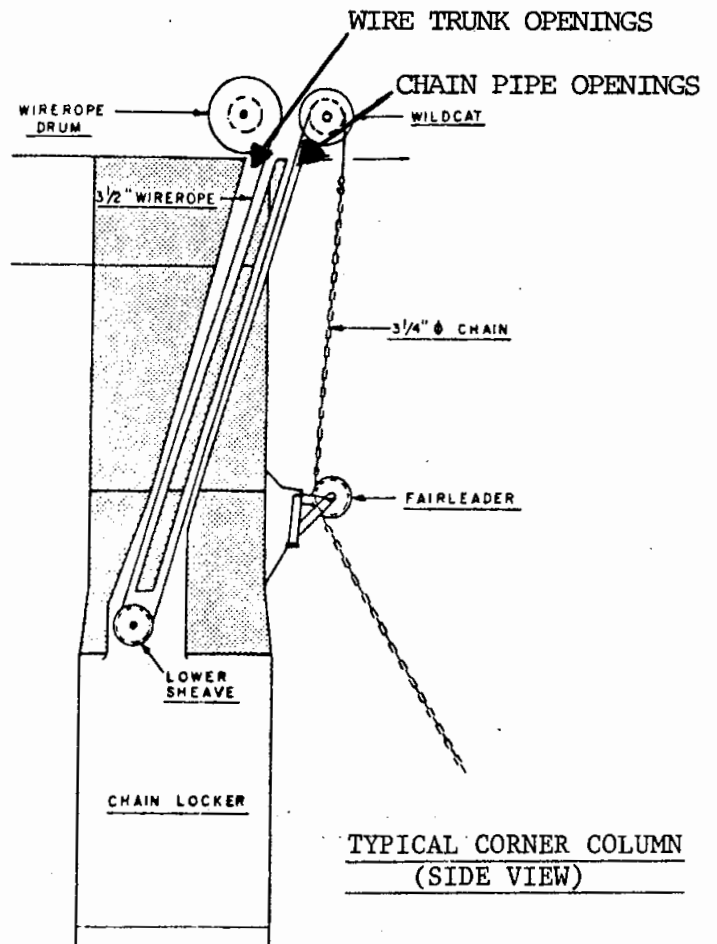
COMBINATION MOORING SYSTEM

WIRE TRUNK
OPENINGS (approx. 25 sq.ft./ea)

CHAIN PIPE
OPENINGS
(approx. 6 sq.ft./ea)

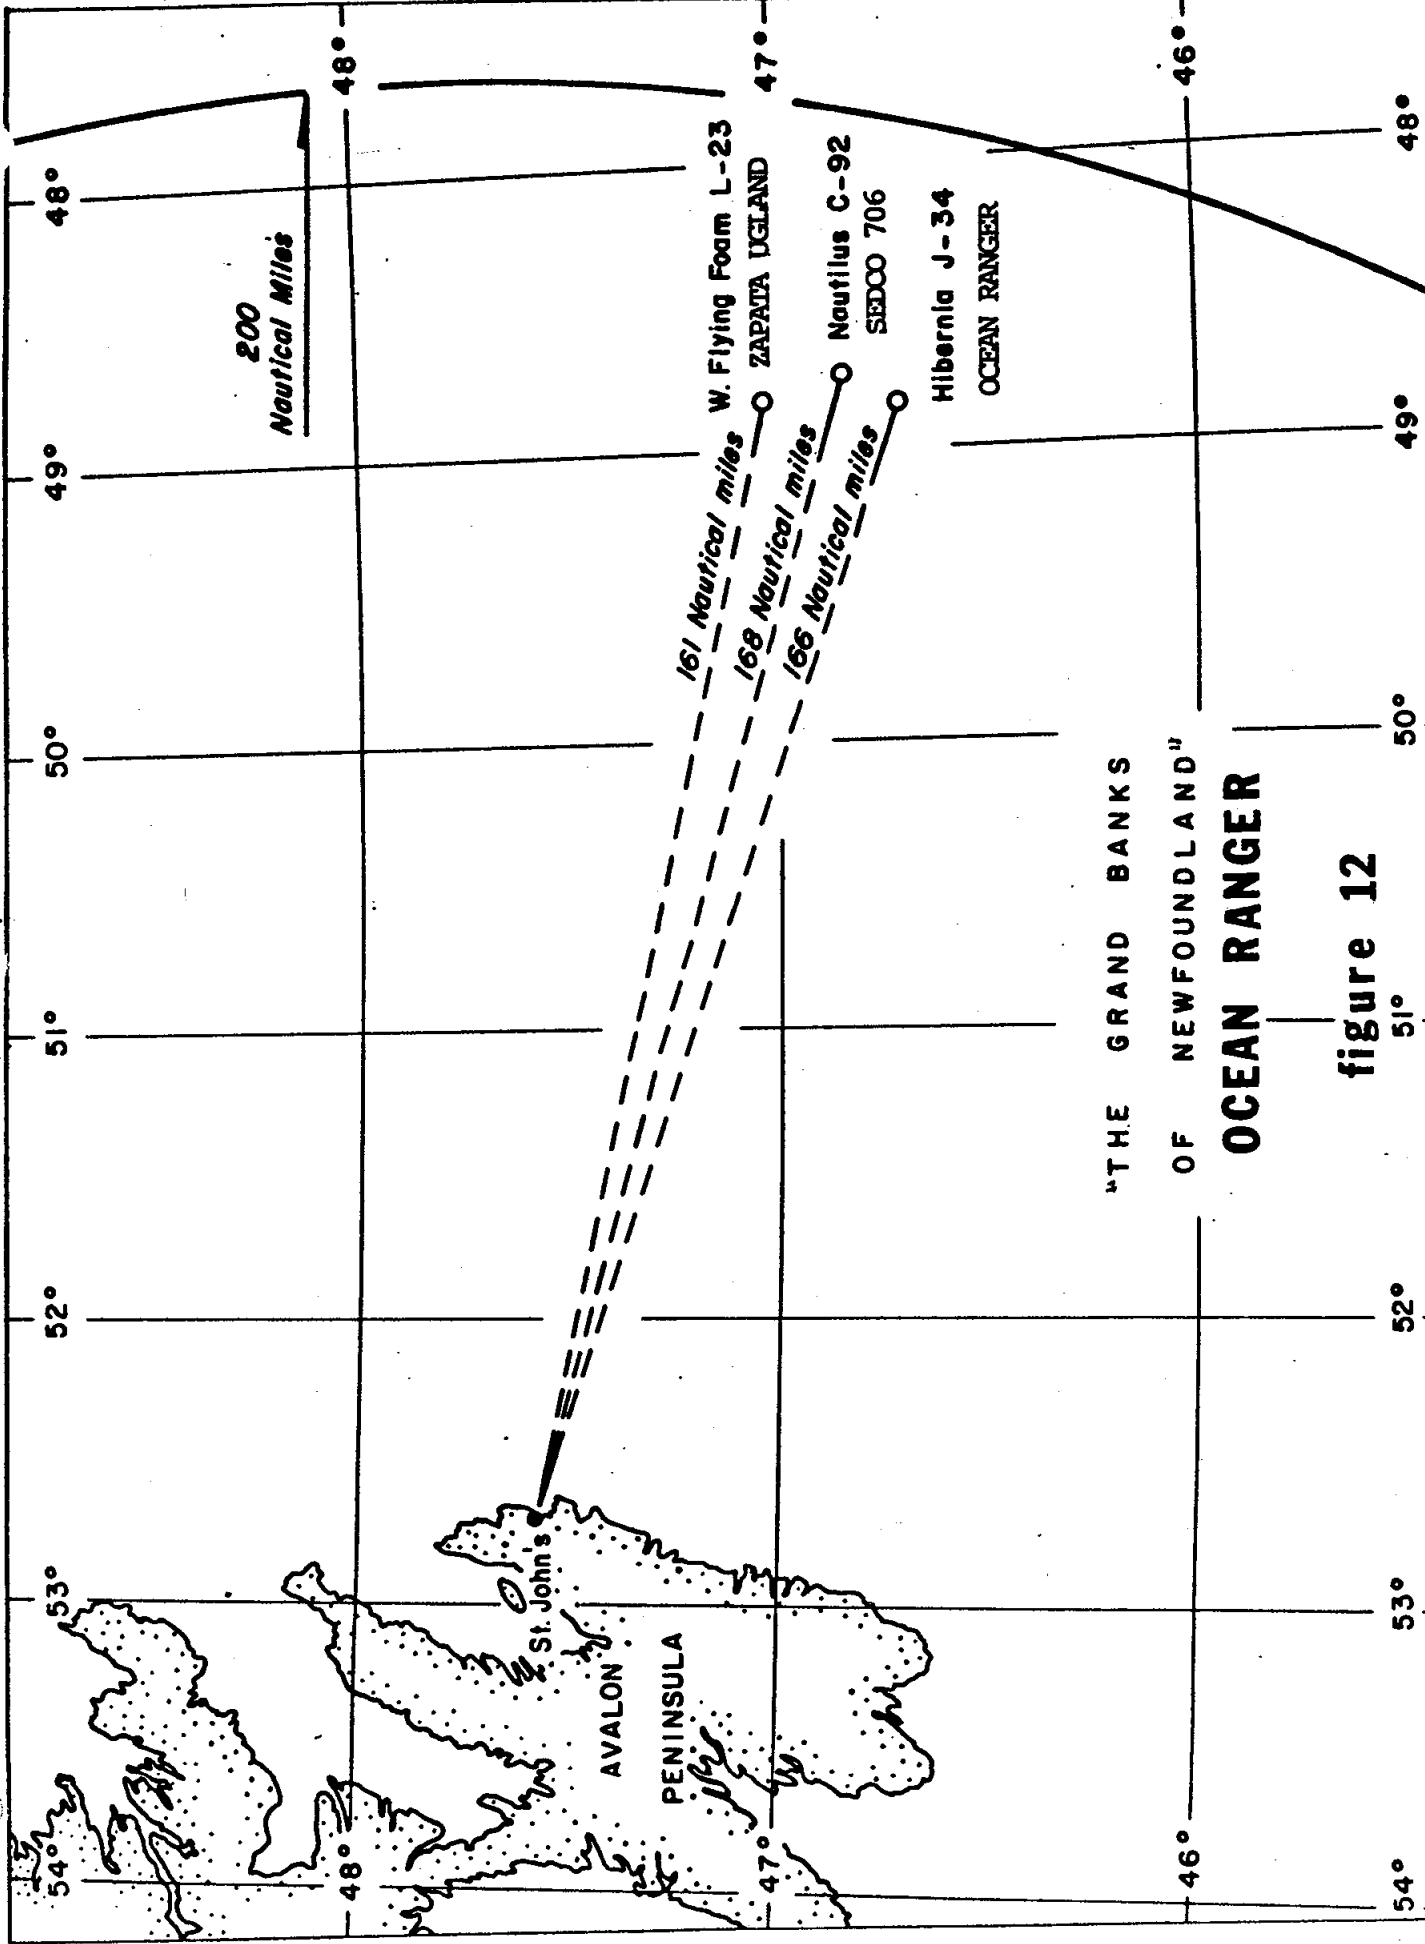
figure 12

OCEAN RANGER began drilling operations on 6 November 1980 on the Grand Banks off Newfoundland under contract to MOCAN. It worked at two well sites in the Hibernia Field before drilling the well designated Hibernia J-34 on 26 November 1981. The location, shown on figure 12, was in approximately 260 ft of water with the OCEAN RANGER on a heading of 310 degrees. Figure 12 also shows the location of two other semi-submersible rigs, SEDCO 706 which was 8.5 miles NNE and ZAPATA UGLAND which was 19.2 miles N of OCEAN RANGER. Drilling operations continued around the clock by two crews alternately working a tour of 12 hours. Generally the rig's complement of personnel worked 21 days on and 21 days off.

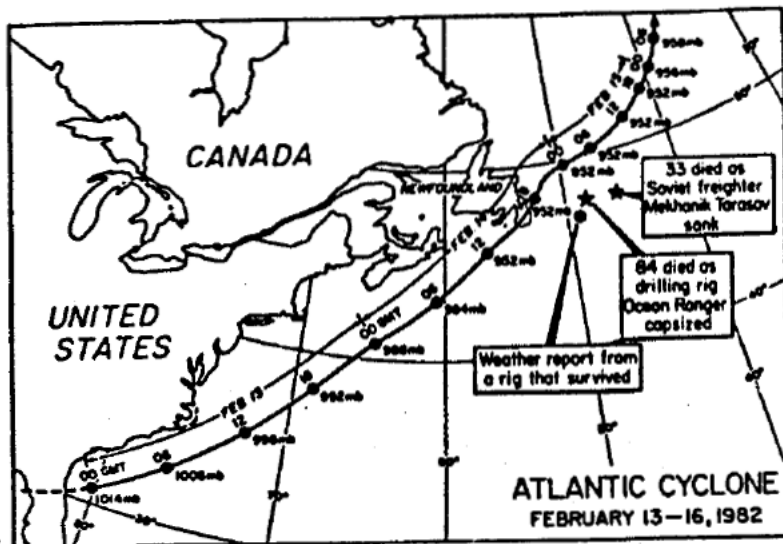
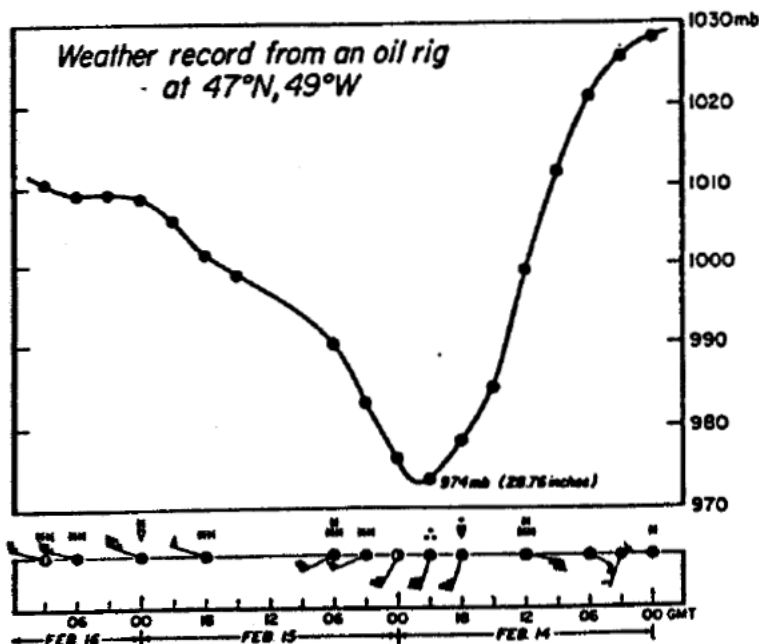
The storm associated with the OCEAN RANGER casualty was a major Atlantic cyclone. Figure 13 shows the storm track and the on-scene weather at the site of the casualty.

Figure 38.—The track of this vicious storm with 6-hr pressures, and the weather record from a nearby oil rig (47°N, 49°W). A total of 117 deaths resulted from this storm. From *Storm Data*, Feb. 1982, prepared by Prof. [redacted], University of Chicago.
