# United States Coast Guard

## MISLE Incident Investigation Report For

GOLDEN RAY - Capsizing

Subj: FORMAL MARINE CASUALTY INVESTIGATION CONCERNING THE CAPSIZING AND  
FIRE OF THE RO/RO GOLDEN RAY WHILE TRANSITING ST. SIMONS SOUND,  
GEORGIA ON 08 SEPTEMBER 2019.

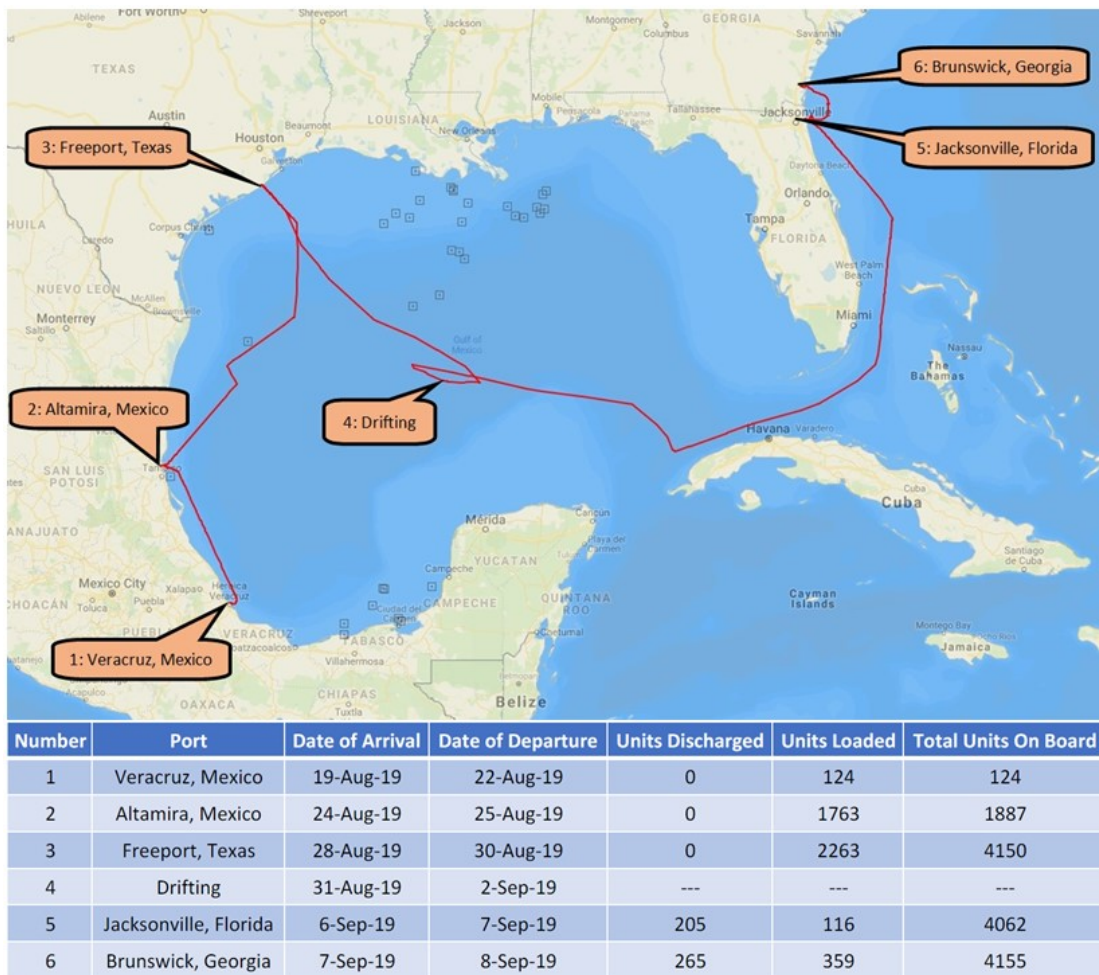
Figure 2. Summary of GOLDEN RAY voyage generated from VDR data by RMI

4.1.1. The GOLDEN RAY was a RO-RO vessel flagged in the RMI, designed to carry a maximum of 7,742 vehicles. It frequented ports around the world since its delivery date in 2017. The vessel had no history of marine casualties and was in compliance with all applicable certificates. Figure 2 depicts the overall route of the vessel for this voyage.

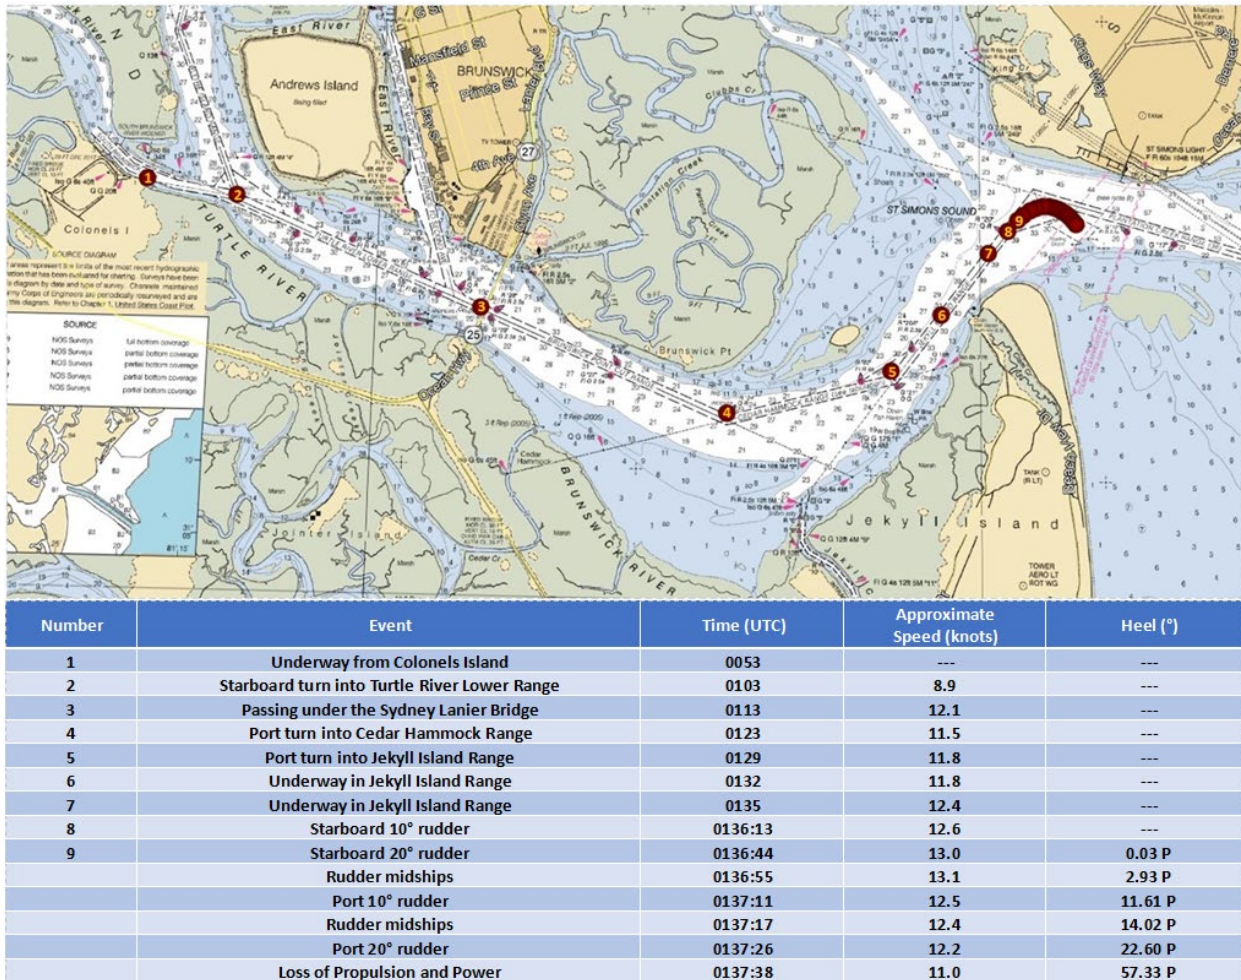
Figure 3. Summary of maneuvers during outbound transit generated from VDR and PPU data by RMI

4.1.3. The following sequence of maneuvers depicted in Figure 3 summarize the voyage from Brunswick, Georgia. Records from the vessel’s computer listed the following doors as “open” during these maneuvers: Deck 5, Door 0 (access to aft stairtower) and Door 47 (entrance to stairtower that accessed the Engine Control Room (ECR)). The locations of these doors are depicted in Figure 4.

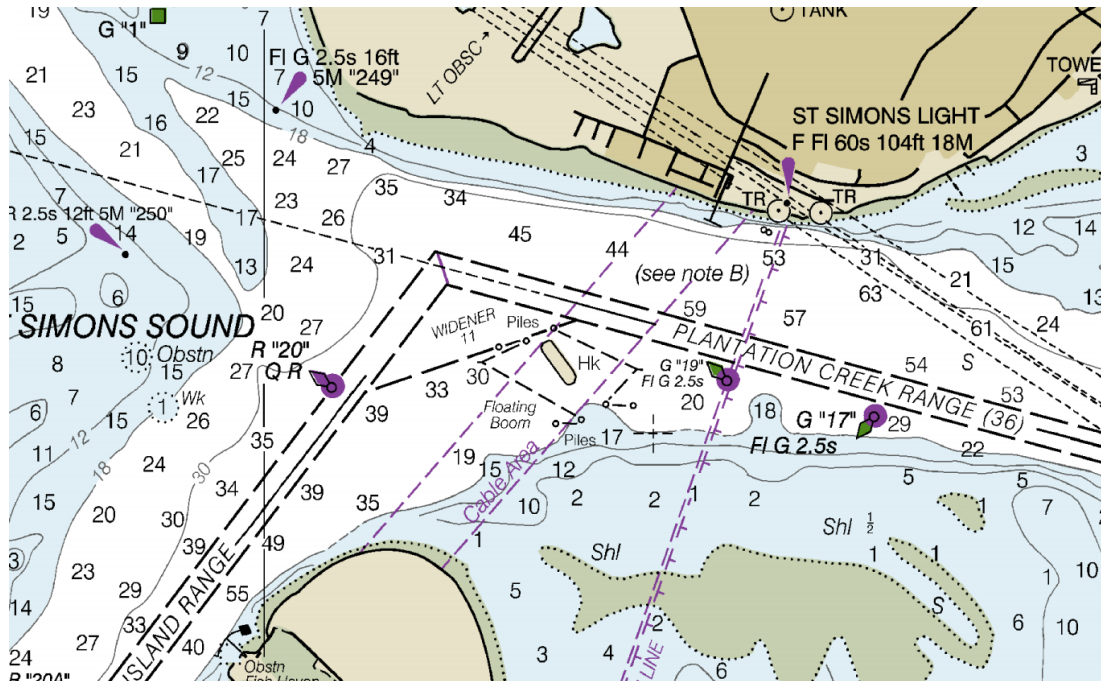
Figure 6. Widener 11 on NOAA Chart 11506

4.1.7. At 0136, the GOLDEN RAY entered Widener 11 near the St. Simons Fishing Pier. A “widener” is defined as an area in which a vessel can maneuver between two channels that is wider than the channel. This area is depicted in Figure 6 by the red triangle. As the vessel transited Widener 11, the crew experienced a sudden unexpected heeling to port. The Pilot asked the Master, “Captain, what’s the GM on this thing?” No response was recorded on bridge audio. GM is the metacentric height and a factor in the overall stability of the vessel. In making the turn through Widener 11, the Pilot ordered 20 degrees starboard rudder at 0136 and then midships, but the vessel continued to make a starboard turn. The Master ordered a hard port rudder.

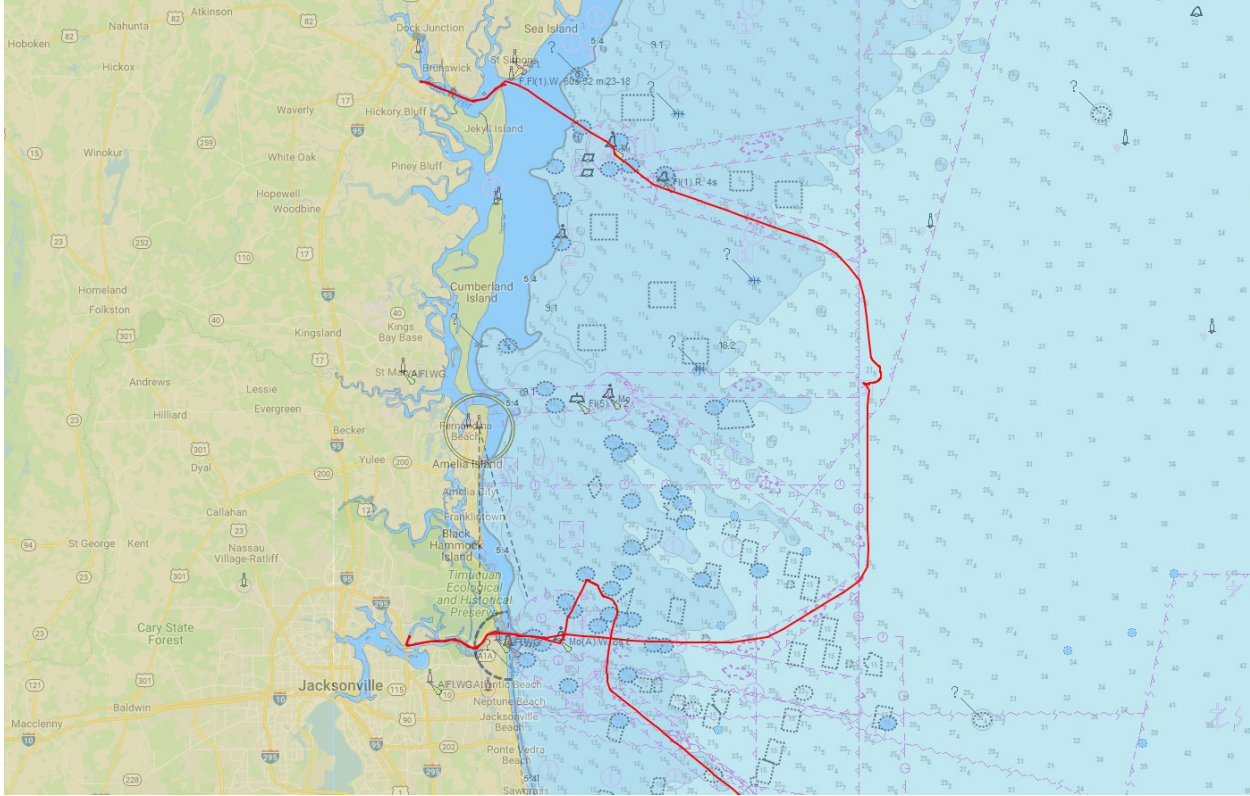
Figure 8. Vessel trackline from Jacksonville to Brunswick derived from LRIT and AIS

4.2.2.1. *Port of Jacksonville and Outbound Transit.* The Port of Jacksonville, Florida, at Blount Island Terminal is located 12.5 nautical miles from the sea buoy. The GOLDEN RAY called on Berth 22 in Blount Island on September 6, 2019. Figure 8 depicts the trackline for this transit.

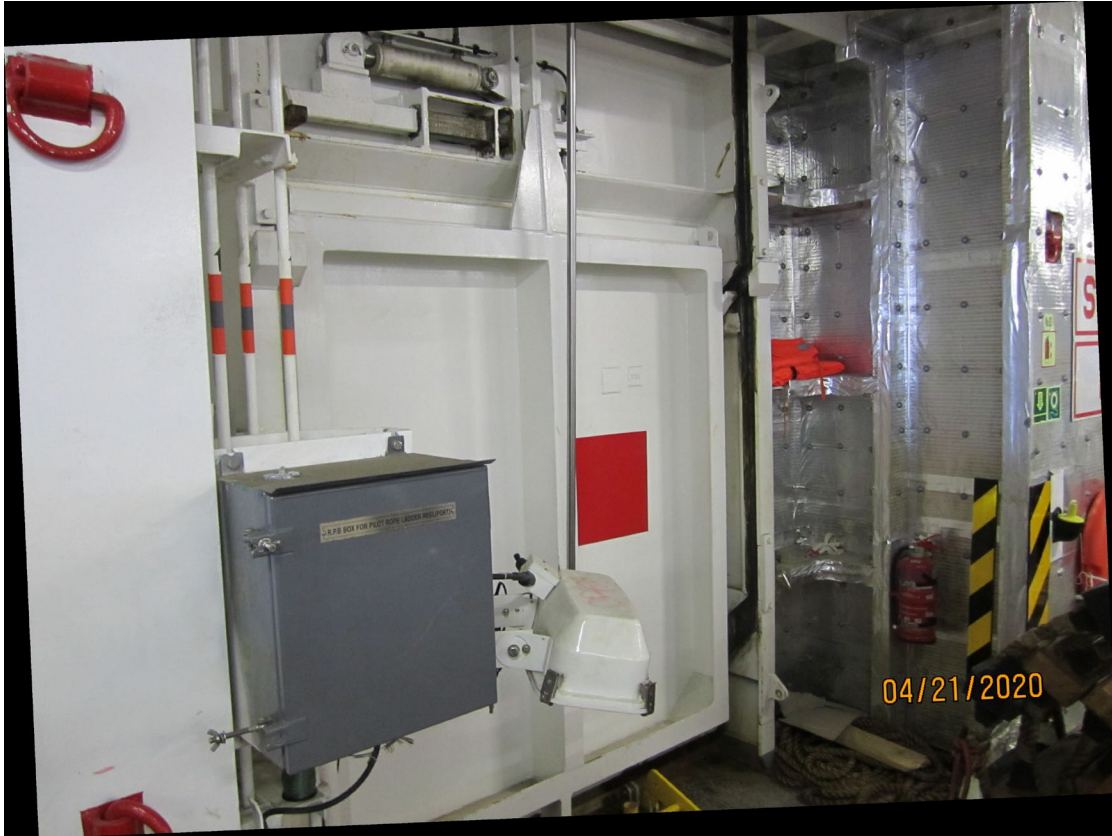
transits with a pilot onboard. It is considered a watertight door completely open to Deck 5, as pictured on the SILVER RAY in Figure 11 and Figure 12. Deck 5 is considered part of the watertight envelope of the vessel and contained an aft and midship access to stairtowers noted in section 4.1.8.

Figure 12. Photo of SILVER RAY Pilot Door closed taken from inside vessel by USCG

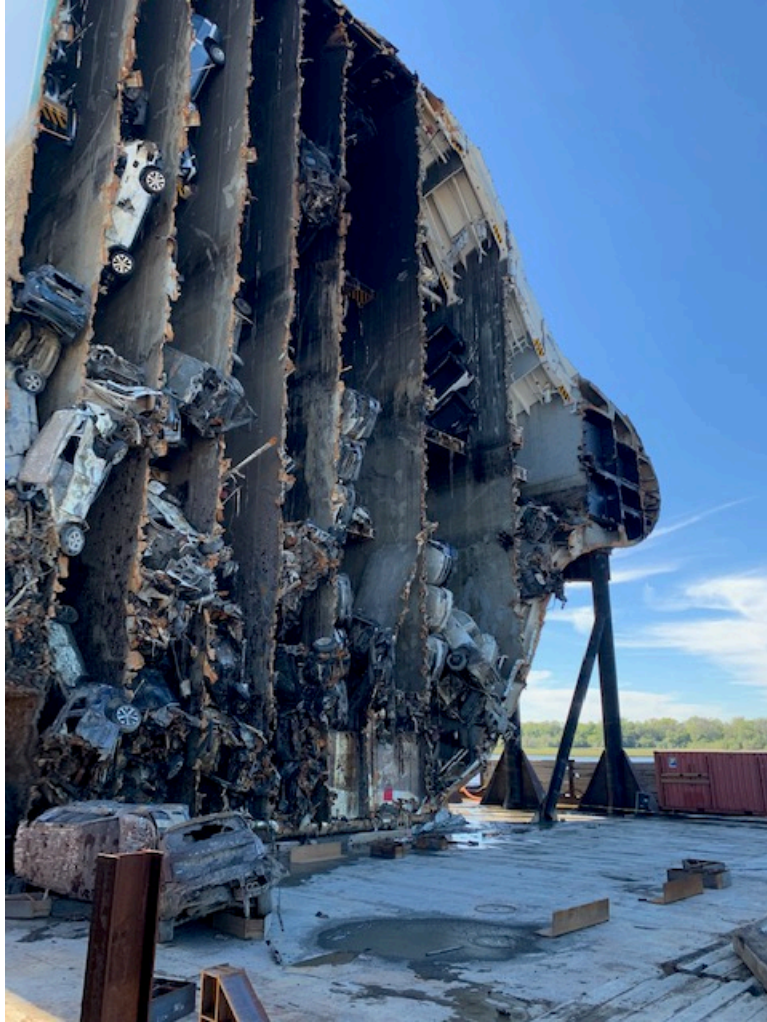
5.14. *Cargo Securing Manual (CSM).* SOLAS Chapters VI and VII require a CSM, approved by the flag Administration, to be provided on all types of vessels engaged in the carriage of cargoes other than solid and liquid bulk cargoes.<sup>19</sup> During this investigation, consideration to cargo securing was given. Evidence did not indicate there was any issue with how vehicles were secured on the GOLDEN RAY. The lashings were provided by the vessel and vehicles were lashed in accordance with the CSM. While the dangerous conditions on board prohibited investigators from confirming that all vehicles were properly secured, it is assumed based on the testimony of the stevedores and crew, that all vehicles were properly secured. Further, salvage of the vessel included 3D scanning of the cargo decks, as pictured in Figure 16. Even after the capsizing and grounding, many of the vehicles on board were held in place by their lashings. This remained the case even as the vessel was salvaged two years later, as pictured in Figure 16.

Figure 16. Photo taken during salvage operations by USCG in 2020
