REPORT OF INVESTIGATION INTO THE SINKING AND LOSS OF TWO CREW MEMBERS ABOARD THE COMMERCIAL FISHING VESSEL LADY LUCK

IN THE GULF OF MAINE
ON 01/31/2007

MISLE ACTIVITY NUMBER: 2865282

INVESTIGATING OFFICER'S SUPPLEMENTAL REPORT
REGARDING THE SINKING AND LOSS OF TWO CREW MEMEBERS
ABOARD THE COMMERCIAL FISHING VESSEL

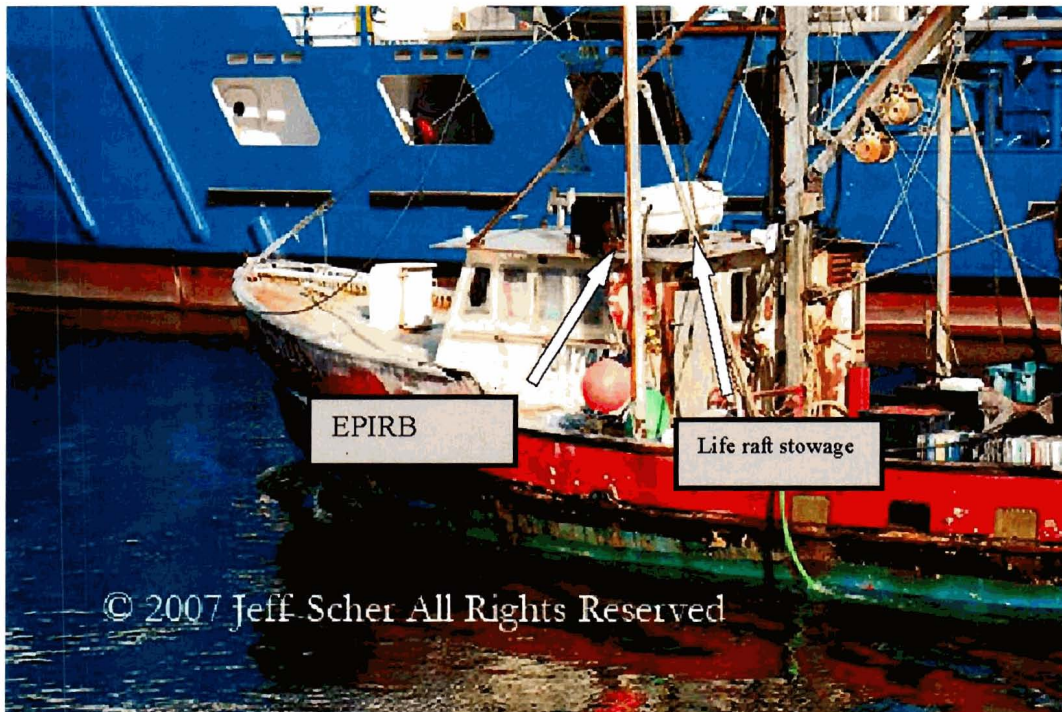
EQUIPMENT	NOTES
(1) inflatable life raft	Stowed on top of pilothouse Deployed during sinking but the sea painter never separated from the vessel
(1) EPIRB category 1 (406 MHz) (Emergency Position Indicating Beacon)	Battery expires January 2012 Re-registered with NOAA January 18, 2007 Beacon ID # ADCD04C62541401
Survival suits	Serviceable Stowed over table in pilothouse via bungee cords
Type 1 Personal Floatation Devices (Lifejackets)	Serviceable Stowed in pilothouse
(1) Ocean Service distress signal kit	Serviceable
(1) VHF-FM Radio	Installed Undetermined if radio was equipped with Digital Selective Calling (DSC).
