UNITED STATES COAST GUARD

TUG VALOUR

40 MILES OFF THE COAST OF WILMINGTON, NORTH
CAROLINA ON JANUARY 18, 2006 WITH MULTIPLE
LOSS OF LIFE

Subj: TUG VALOUR REPORT OF INVESTIGATION

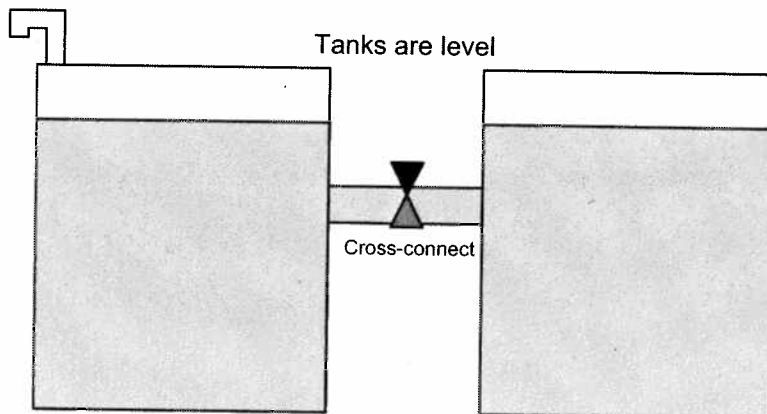
to approximately 6% of the permeable volume. Based upon the static angle of heel, limited righting energy, and submergence of the aft deck, the VALOUR would have had negligible stability and probably could not have stayed upright in the 12-20 ft seas reported at the time of the casualty. Once the VALOUR heeled over enough for continuous downflooding through the port engine room vents, sinking was inevitable. Determining the amount of time it takes for pairs of tanks to hydrostatically balance is difficult, especially taking into account the unknown but extreme vessel roll dynamics at the time of the casualty. However, assuming the difference in the fluid levels of the largest pair of tanks (#5 port and starboard fuel tanks) was 5 ft and the tanks were connected by a straight 10 ft section of 2.5 inch diameter pipe, the maximum initial flow rate would be approximately 210 gallons per minute. The modeling indicated that in balancing between successive conditions, a pair of tanks would need to transfer at most 2,700 gallons. Given the assumptions above, which are not exact to the actual conditions on the VALOUR, the balancing time would be at least 13 minutes. In practice it would take longer because of the differences in head pressure, piping diameters, piping configuration, the presence of multiple fittings, and the quantity of liquid to be transferred.
