UNITED STATES COAST GUARD

REPORT OF INVESTIGATION INTO THE COLLISION AND FIVE FATALITIES ONBOARD THE **M/V ZIM MEXICO III AND THE OSV LEE III**

IN THE SOUTHWEST PASS OF THE MISSISSIPPI RIVER
ON 02/21/2004

FORMAL INVESTIGATION INTO THE COLLISION OF THE M/V ZIM MEXICO III (IMO #9063988) AND THE OSV LEE III (O/N 542918) AT MILE MARKER 8 ON THE SOUTHWEST PASSAGE OF THE MISSISSIPPI RIVER ON 21 FEBRUARY 2004, RESULTING IN THE SINKING OF THE LEE III AND LOSS OF FIVE LIVES.

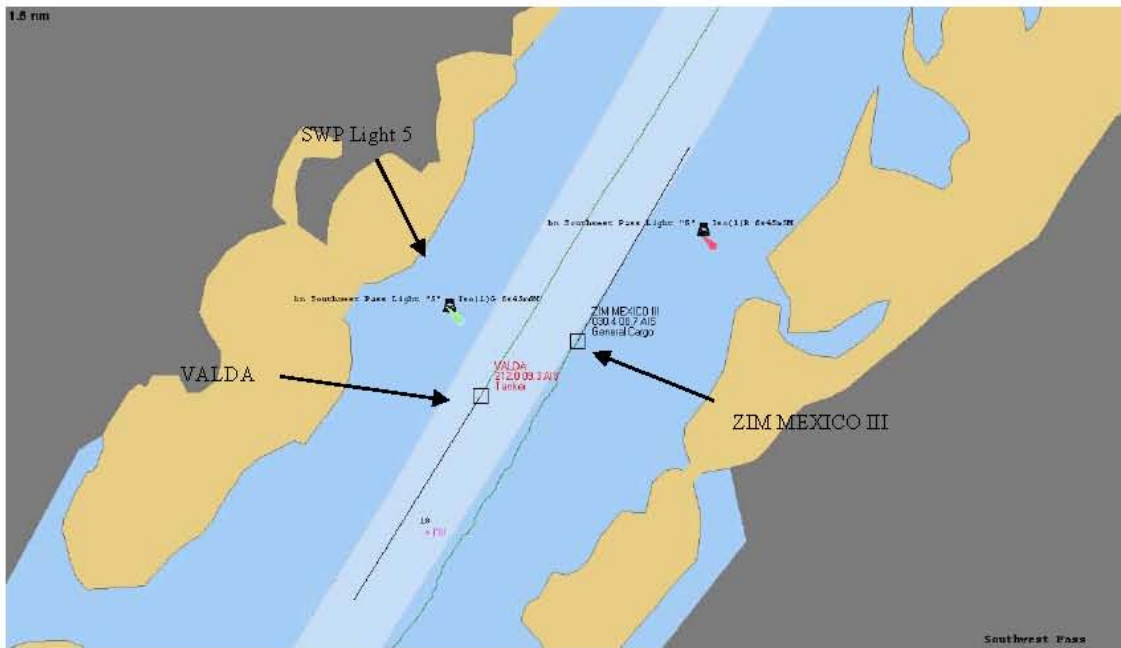
Figure 1: ZIM MEXICO III AIS Track as it Passed Southwest Pass Light 5

16. The data in Table 6 shows the vessel made a normal transit up Southwest Pass from the sea buoy to Light 16. The Pilot of the ZIM MEXICO III navigated the vessel past the sea buoy, into Southwest Pass, and up the river without incident. He used channel 67 to make passing arrangements with various southbound vessels. The AIS data reflects the fact the ZIM MEXICO III slowed down to a speed of six knots when it passed the construction site for the new pilot station and then increased in speed after going by as discussed above. It also shows, when watched on the animation provided by the VTS, that while transiting past the new pilot station construction site the Pilot safely took the vessel outside of the eastern limits of the charted channel. He reentered the channel after passing the M/V VALDA at Light 5. The Chief Mate testified that the minimum speed the ZIM MEXICO III can make in still water and maintain steerage is around 2.6 knots and that into a current of three to four knots the vessel would need to be making around six knots. He also testified that when the vessel slowed to 6 knots at the construction site they had no trouble maneuvering at the reduced speed. See Figure 1.

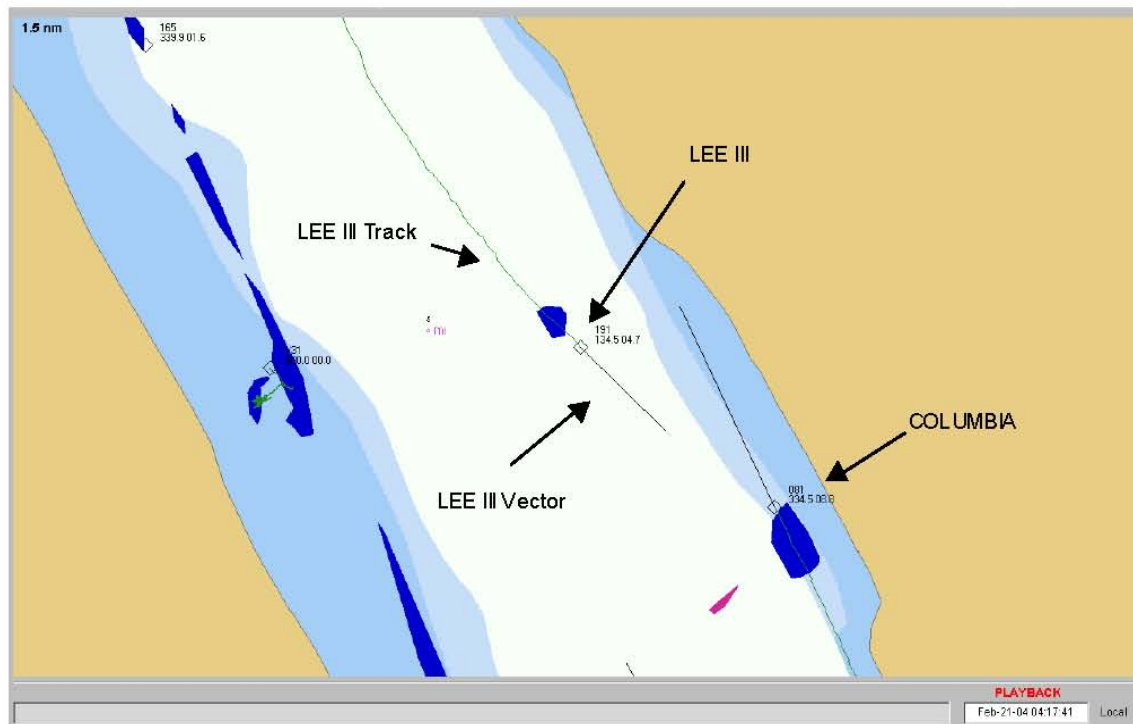
Figure 5: LEE III at 04:17:40; Hails “That Tow,” & Heading Towards COLUMBIA

17. At 04:17:40 the LEE III called on Channel 67, “LEE III calling that tow,” but received no response. At that time the LEE III was making its way over to the east side of the channel as shown in Figure 5. Captain [REDACTED] stated that he spotted the LEE III visually $\frac{3}{4}$ miles away and that the LEE III was heading towards the COLUMBIA at the time. After calling “that tow,” and not receiving an answer, the LEE III then began to turn slightly to starboard and headed down river to pass the COLUMBIA port-to-port as agreed upon earlier.

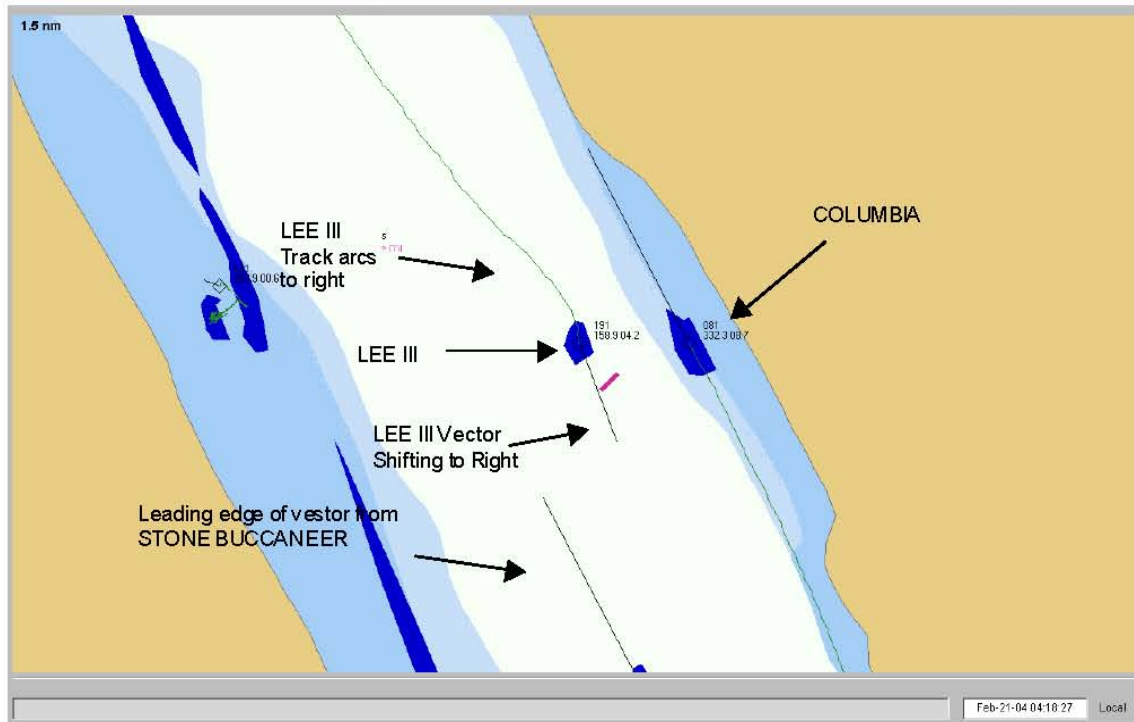
Figure 7: LEE III at 04:18:27; Passing COLUMBIA

22. It was at approximately the time of the 04:18:11 – 04:18:27 conversation that the LEE III executed this turn to port. It is likely that the LEE III turned a full 360-degrees to port in the process. If it had stopped at a 180-degree turn, it would have been on a northerly heading back up the river—the opposite direction it ultimately went. Assuming that the LEE III continued its turn to port past 180-degrees and to a full 360-degrees, this would have momentarily put the STONE BUCCANEER off of the LEE III’s port bow as the LEE III continued to come around. At 04:18:53 the LEE III told the STONE BUCCANEER, “Ya, you’re actually right now, you’re on my port bow. I kind of got nervous here and slowed down and swung around here, over.” See Figure 7.

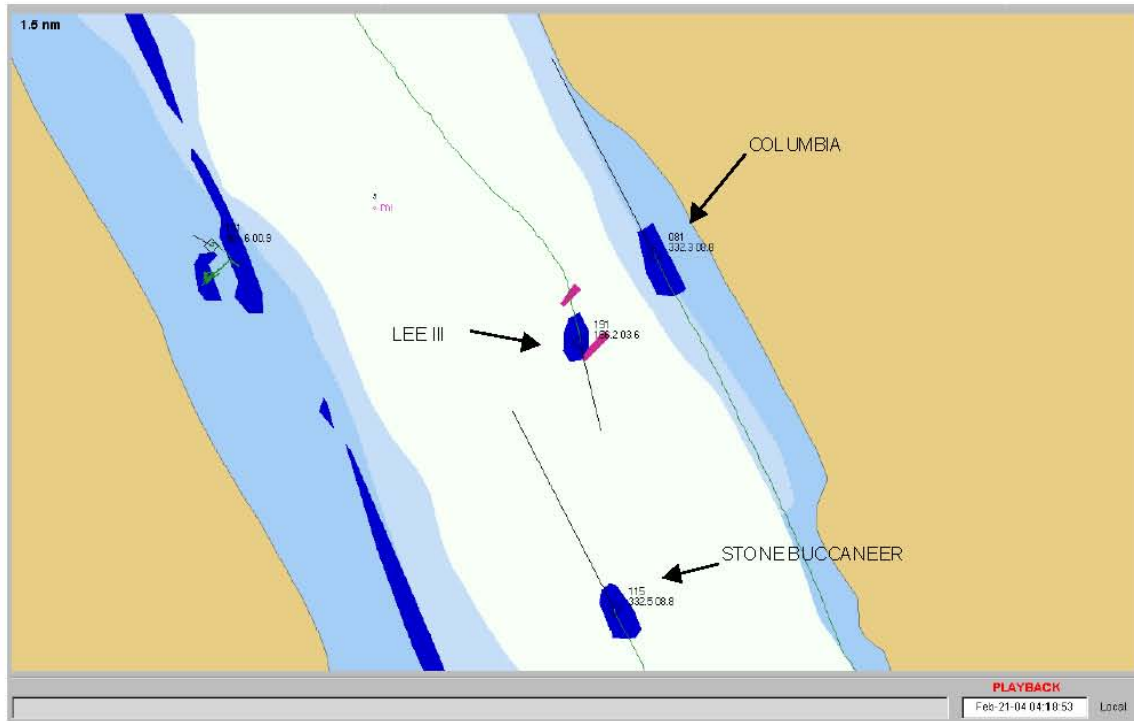
Figure 8: LEE III at 04:18:53; Astern of COLUMBIA; STONE BUCCANEER off Port Bow

23. Regardless of the actual nature of the “situation” that the operator of the LEE III felt that he was in, it is clear that he was in doubt as to “who’s who and what’s what” while passing these two vessels. One can only speculate as to why this happened. Figure 8 shows the track of the LEE III as it passed the STONE BUCCANEER. It clearly shows that the LEE III performed a series of maneuvers while passing the COLUMBIA and the STONE BUCCANEER despite the fact that there was ample room for it to pass between both vessels without having to maneuver as it did.
