N-CFSAC

Supporting Documentation Package 2

MISLE Incident Investigation Report For FV RANDI - Sinking/Loss of Life

Subj: CFV CAPT JOHN REPORT OF INVESTIGATION

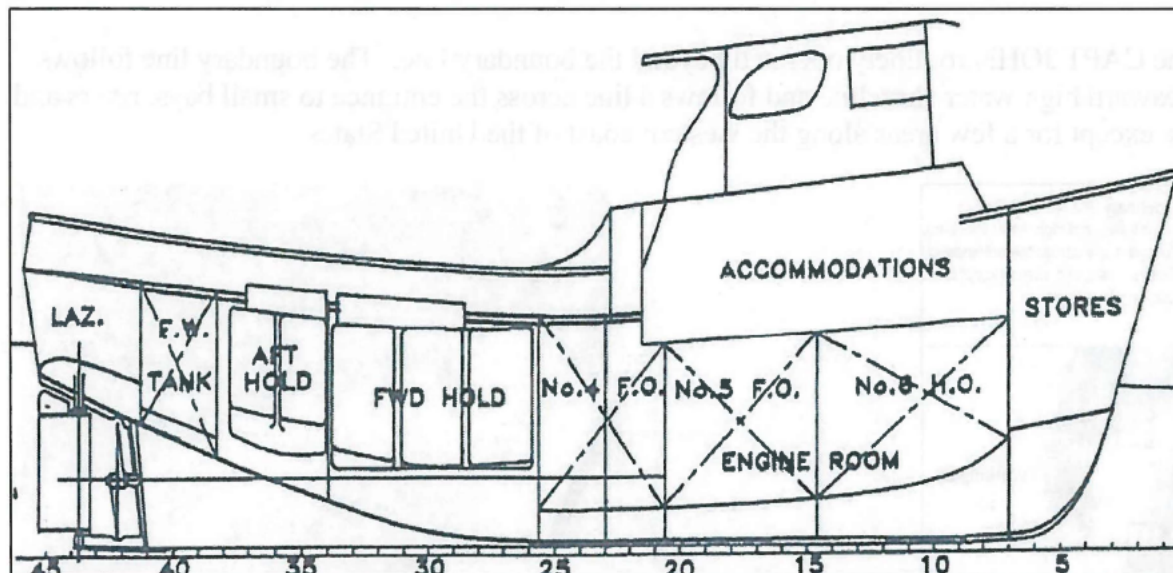
Schematic of CAPT JOHN's Sister Vessel, GRANADA

5. Each transverse bulkhead on the CAPT JOHN had limber holes drilled into the bottom. It is unknown if these limber holes were original to the vessel as the plans for its sister vessel, GRANADA, showed bilge piping installed through watertight bulkheads that lead to a bilge manifold or pumps. Though not required on commercial fishing vessels built prior to 1991 and less than 79 feet, the GRANADA was designed with subdivision consisting of eight watertight compartments. The purpose of the limber holes were to allow water to drain forward/aft to the fish-hold and from there to be pumped overboard. The CAPT JOHN's owner and crew could not produce a specific need for the limber hole modifications that differed from the sister vessel GRANADA's plans.
