UNITED STATES COAST GUARD

**MARINE BOARD'S REPORT
INTO THE
IMPLOSION OF THE SUBMERSIBLE TITAN
(CG 1788361) IN THE NORTH ATLANTIC OCEAN
NEAR THE WRECK SITE OF THE RMS TITANIC
RESULTING IN THE LOSS OF FIVE LIVES
ON JUNE 18, 2023**

MISLE ACTIVITY NUMBER: 7724663

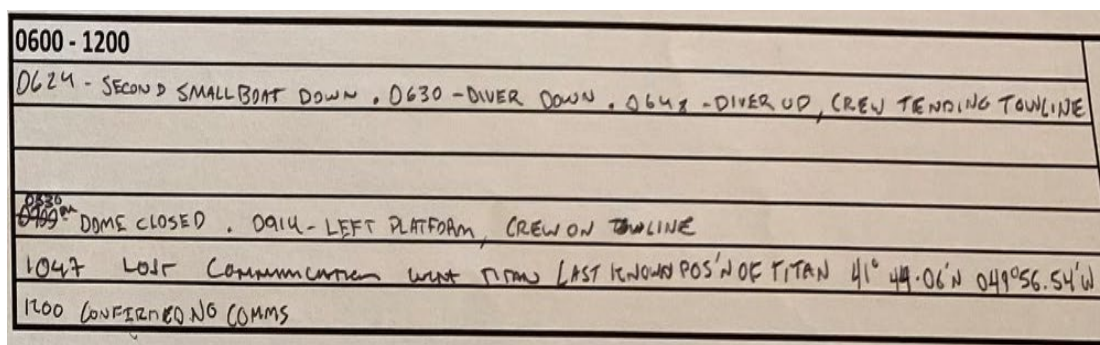
4.1.59. At 11:15 a.m., the Master of the POLAR PRINCE was advised that as of approximately 10:47 a.m., there was a loss of communication with the TITAN. The Master of the POLAR PRINCE stated in a written response to the MBI that, “this was not perceived to be an emergency by OceanGate and that was communicated to me.” An entry was then made into the POLAR PRINCE logbook, it stated “1047 lost communication with TITAN.”

Figure 37: Photo of the POLAR PRINCE Logbook entry for 0600-1200 watch on June 18, 2023, taken by the MBI post-casualty. Source: USCG, June 25, 2023.

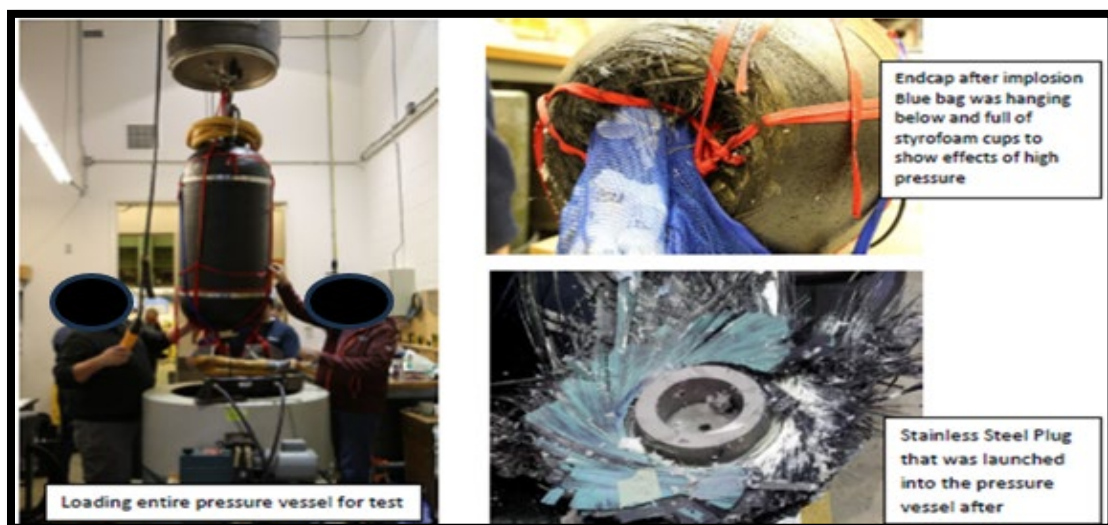
“As many of you already know, we conducted a pressure test of a one-third scale model of our Filament Wound Carbon Fiber (FWCF) hull. At a pressure of 4,285 psi (the pressure at approximately 10,000-feet of depth) one of the hemispherical endcaps failed just outboard of one of the large stainless-steel inserts. While the failure was unexpected at this depth, it was well short of the design operating depth of 20,000 feet, a FWCF hemisphere was always viewed as an extreme technical challenge. Even Boeing with all their computer capacity admitted they were unable to analyze such a structure. Fortunately, there was no damage to the main cylindrical section, which is the critical part and a shape that is far better understood.

After an initial review yesterday by Spencer Composites (fortunately our new Board member, was able to fly the failed components to them within 5 hours of the failure), it is believed that the hemisphere buckled which was the reason our strain gauges did not give us warning of the failure. For the next test we will include acoustic monitoring which should give a better warning of this type of failure. Being able to consistently predict a pressure vessel failure is a key to ensuring we have a safe system that can operate for many years in varied conditions.”

Figure 75: Excerpt from the Mr. Rush's letter to the stakeholders, December 23, 2015: Source: UW-APL.

4.12.6. The failure of the composite endcap prompted OceanGate to discontinue the use of composite end caps in favor of metallic alternatives—specifically titanium, aluminum, or steel. These materials would undergo testing over the next year to evaluate their compatibility with the pressure vessel. Mr. Rush underscored the achievements made so far, emphasizing that OceanGate’s core business model prioritizes "extreme efficiency."

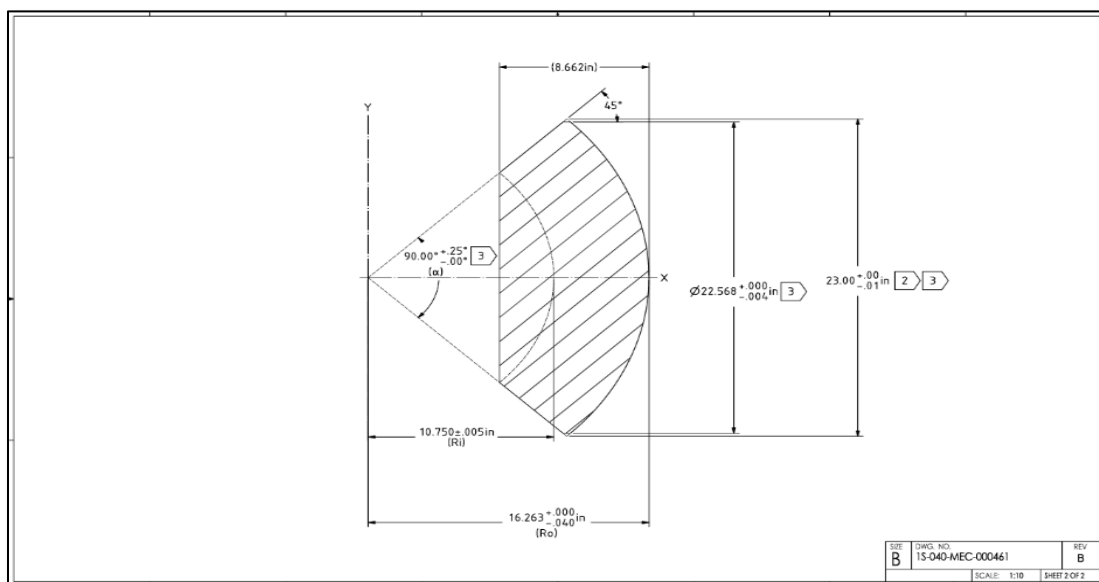
OceanGate submitted a purchase order to Hydrospace Group, Inc. (HSG) to create a 23-inch acrylic frustum dome designed for use with PVHO materials certification. The window was intended to meet the PVHO certification requirements and was priced at \$33,450. However, OceanGate specifically requested a conical external facing shape and a flat internal facing shape dome window, which would provide better viewing from inside the submersible. This window design, as proposed, was not an approved PVHO geometry, meaning it did not comply with established pressure vessel standards for human occupancy.

Figure 90: Acrylic Window Drawing for TITAN. Source: OceanGate.

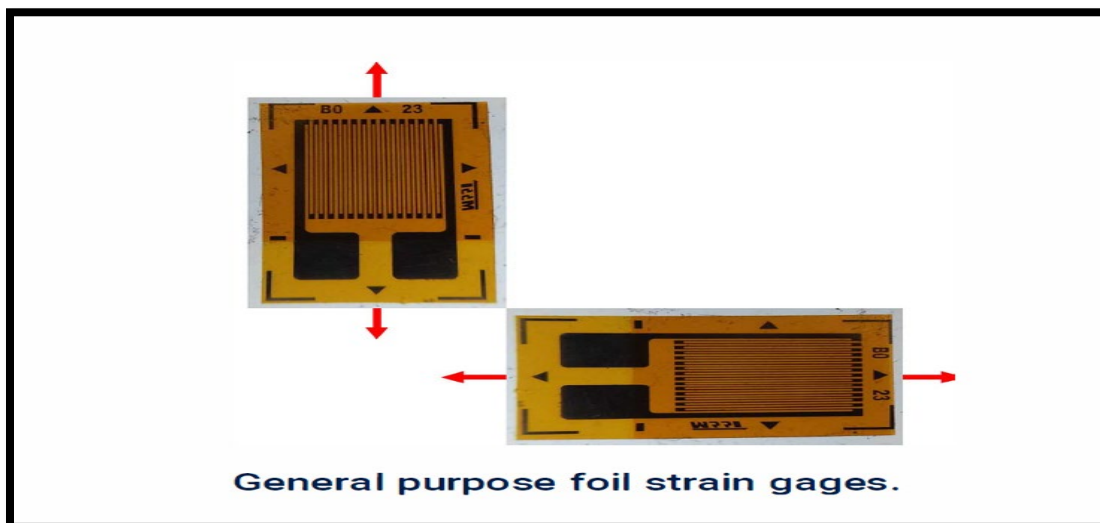
Figure 102: Example of TITAN's strain gauging. Source: NTSB Materials Laboratory Factual Report.

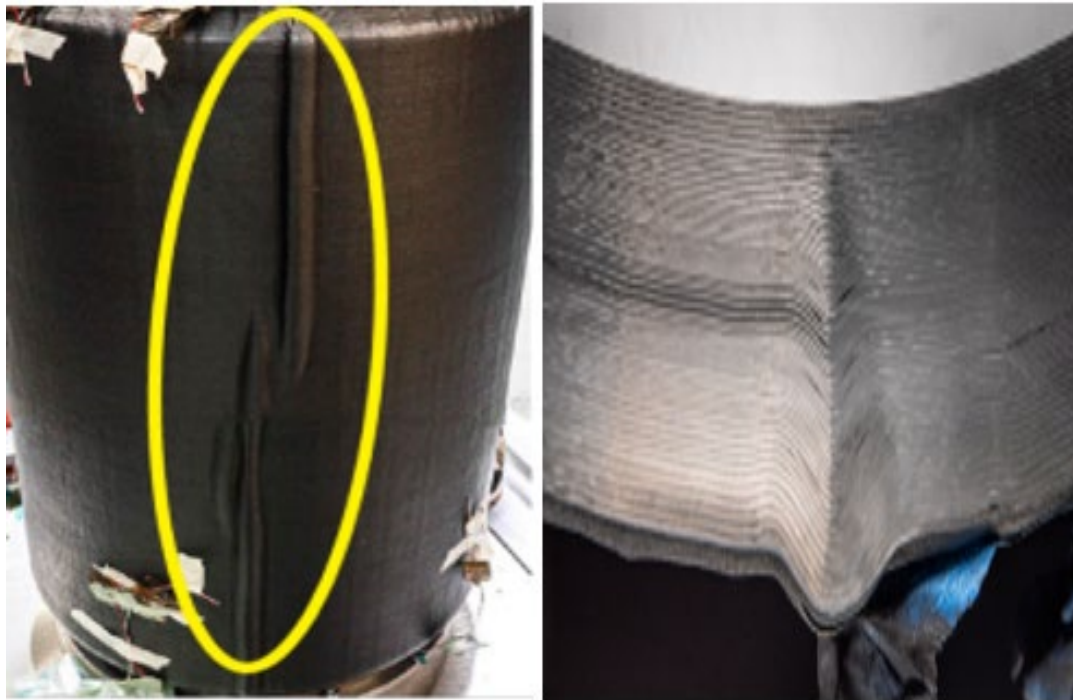
4.27.2.3. After the cure, large wrinkles were identified in the one-third scale model.

Figure 140: Wrinkles on the surface and cross section cut of one-third scale model for the final TITAN hull post autoclave cure (yellow circle added by MBI). Source: OceanGate.

4.27.2.6. On July 27, 2020, OceanGate conducted pressure testing on a one-third scale model of their hull. UW-APL, which conducted the testing, invoiced OceanGate for 7.25 hours of work. However, a UW-APL representative indicated in an email to a colleague that the test resulted in a catastrophic failure. A subsequent analysis by Collier determined the hull failed at approximately 3,000 meters (9,843 feet). Collier further clarified that the wrinkles observed in the hull (as depicted in Figure 140) would have been particularly vulnerable due to a combination of factors: misaligned hoop fibers not properly aligned with the load-bearing direction, a resin-rich composition within the wrinkle compared to the surrounding laminate, the relative softness of the resin compared to the fibers, and significant delamination within the wrinkle causing voids that were more susceptible to compression than either the fibers or the resin

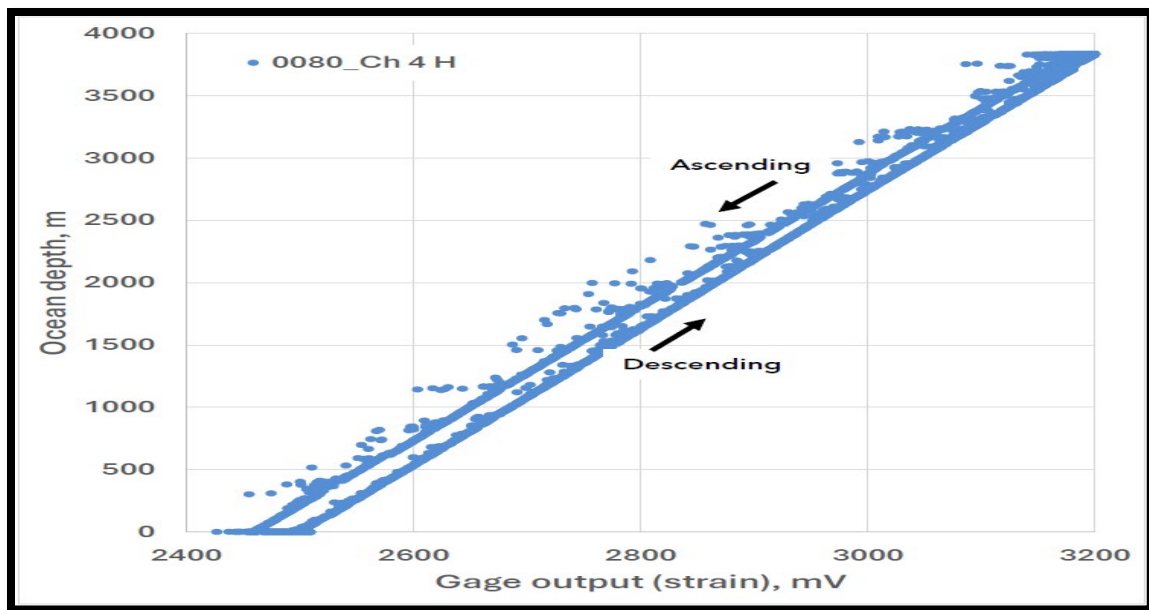
Figure 264: Plot of dive depth as a function of strain gauge output for TITAN's Dive 80 – Gauge Group 4 – hoop strain gauge. Source: NTSB Materials Laboratory Factual Report.

For the remaining TITAN dives that occurred after Dive 80’s large amplitude event, changes were observed in the strain response of the hull, as noted in the NTSB’s report (Appendix B and C). Figure 264 shows the variation in hoop strain gauge output with ocean depth for Group 4 on Dive 80. This was prior to the audible event that was heard by personnel in the TITAN and by support personnel at the surface in a small boat. The audible event occurred as the TITAN was still submerged and approaching the surface. The strain gauge output is plotted on the horizontal axis and ocean depth is plotted on the vertical axis. Because of the strain reduction at depth, the ascent curve is at a lower strain value than the descent curve. Both descending and ascending curves appeared to be linear in Figure 264.
