# **NATIONAL TRANSPORTATION SAFETY BOARD**

## **MARINE ACCIDENT REPORT**

**CAPSIZING AND SINKING OF THE  
U.S. MOBILE OFFSHORE DRILLING  
UNIT OCEAN RANGER OFF THE  
EAST COAST OF CANADA  
166 NAUTICAL MILES EAST OF  
ST. JOHN'S, NEWFOUNDLAND  
FEBRUARY 15, 1982**

NTSB-MAR-83-2

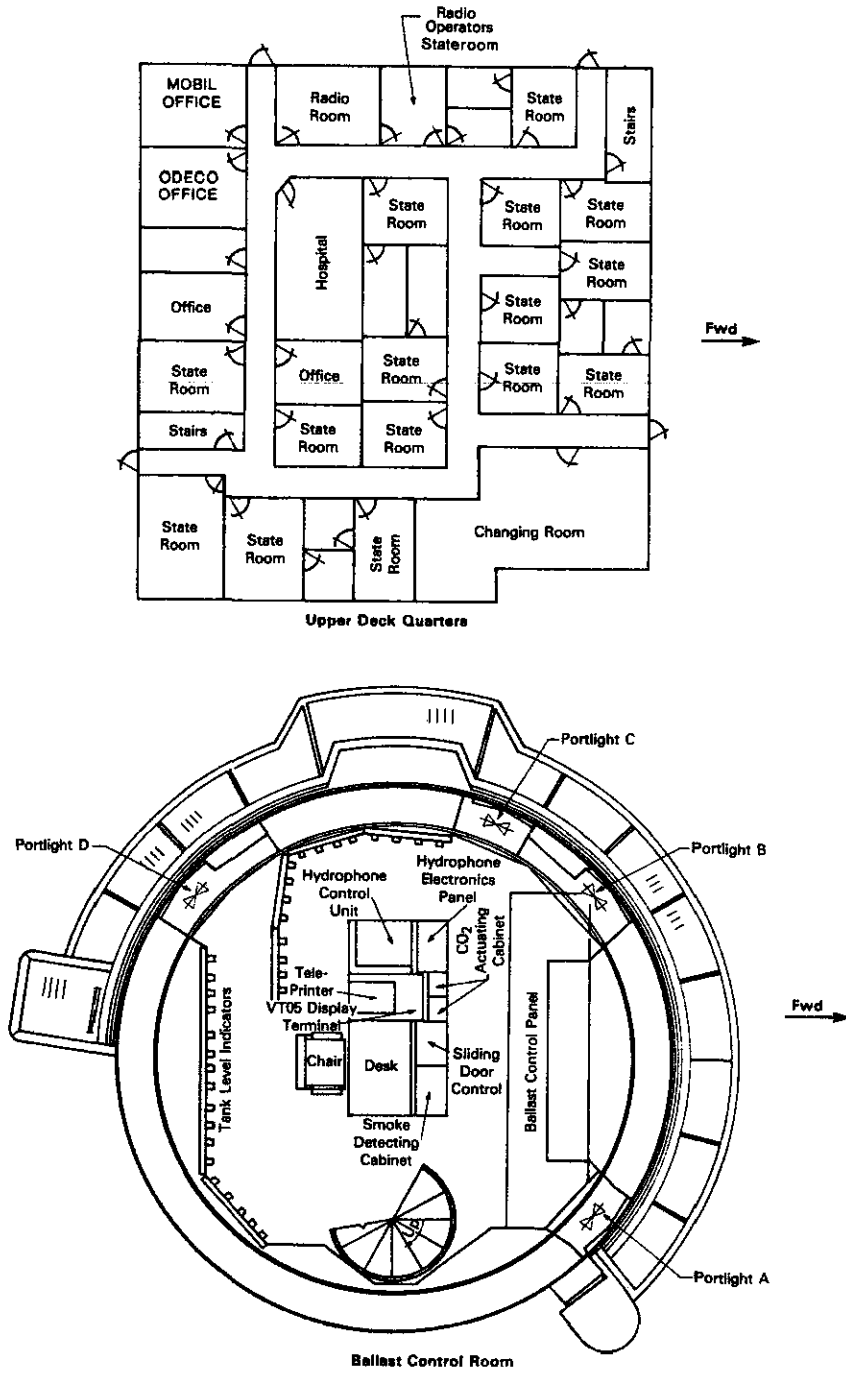
Figure 4.--Upper deck quarters and ballast control room arrangements.

The ballast control room contained the ballast control panel in the forward end of the circular room. One portlight was located on each side of the control panel (see A and B on figure 4); one portlight was located aft of portlight B (see C on figure 4); and one portlight was located in the after end of the control room behind the tank level indicators (see D on figure 4). The portlights were of standard marine design with tempered glass and metal deadlights with securing devices. The port tank level indicators were located on the starboard side of the control room, and the starboard tank level indicators were located on the portside. Two "bubble" type inclinometers were mounted in the control room—one in a fore and aft direction for observing trim, and the other one in an athwartship direction for observing heel. Each inclinometer had two spirit tubes—one with graduations from 0° to 5° and the other one with graduations from 0° to 15°. A similarly mounted pair of inclinometers also were located in the ODECO office. A desk was located in the center of the room with two VHF radiotelephones, sound-powered telephones, and a video display unit with roll, pitch, heave, wind, and wave information. A hydrophone control unit, a carbon dioxide (CO<sub>2</sub>) actuating cabinet, a smoke detecting cabinet, and an H<sub>2</sub>S gas detecting unit were also located in the center of the room. Access to the control room was gained by a circular ladder within the column from the lower deck of the upper hull. On the outside of the column, a vertical ladder was enclosed in a cage leading down from the upper hull to a walkway that extended two-thirds of the distance around the column at the control room level outside all four portlights. A handrail on the column extended around the outside of the portlights, slightly below their centers.

From February 18 to March 2, 1982, a side scan sonar survey was conducted of the wreckage of the OCEAN RANGER. The survey showed the drilling unit resting on the bottom in an inverted position about 500 feet southeast of the wellhead and drill pipe and other debris scattered 900 feet from the sunken drilling unit in a northwest to southeast direction. (See figure 6.) The derrick is located about 200 feet northwest of the OCEAN RANGER. The survey indicated that anchor cables in the fore and aft direction had parted while at least one transverse anchor cable to each corner column remained intact. A videotape survey conducted in early March 1982 did not indicate any structural damage to the hull, except minor damage to the bows of both lower hulls and two broken portlights in the control room. The portlight behind the tank gauges (portlight D, figure 4) and the next portlight near the portside of the control console (portlight C, figure 4) were broken. The deadlights on all control room portlights were found closed.
