## **MARINE SAFETY ALERT**

Safety Alert 04-25

### **IMPORTANCE OF HAZARDOUS ZONE MARKINGS AND SAFETY PROTOCOL AWARENESS**

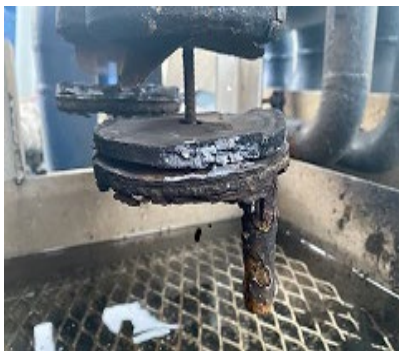
While crew performed assigned work on top of the pilothouse a failed engine purge valve actuator released LNG vapors through the vents located in the crew's work area. Believing the area was gas-free, a crewmember struck a lighter, igniting the LNG fumes and causing severe injury to both crewmembers in the area. This incident shows the critical importance of hazard awareness, proper marking of hazardous zones, and strict adherence to safety protocols.

Figure 2 - Image of methane vent post casualty.

The Coast Guard **strongly recommends** that vessel owners, operators, and other stakeholders:

- Review hazardous zone requirements and ensure crewmembers are fully aware of the circumstances and dangers that define hazardous areas.
- Ensure all hazardous zones are clearly marked and crewmembers are aware of the locations and associated hazards.
