MARINE SAFETY ALERT

Safety Alert 08-24

CORROSION OF LIFEBOAT SELF-CONTAINED AIR SUPPORT SYSTEM CYLINDERS CAN BE DANGEROUS

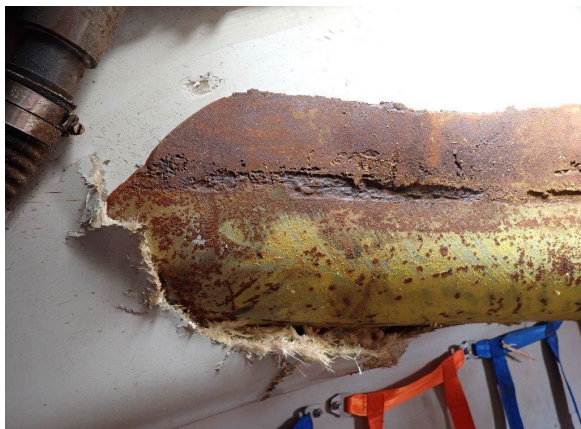
Figure 2: Severely corroded remnants of compressed air cylinder shell. Note the distinct line of deep pitting.

An inspection of the intact cylinder and the ruptured cylinder fragment showed significant corrosion (Figure 2). While the exact cause of the corrosion is unknown, it is suspected that the cylinders were partially submerged in water and subjected to accelerated corrosion due to the

presence of dissimilar metals. Although stray electrical currents were considered as a potential cause, they were deemed unlikely given the lifeboat's electrical configuration and the OCS unit's secured power.

This incident could have been fatal or caused severe injuries if personnel had been nearby. Despite the cylinders having undergone an annual inspection 14 months prior and being within their hydrostatic testing period, the corrosion went undetected. The cylinders were only five years old, but their condition suggested significant deterioration.

The Coast Guard **recommends** that owners, manufacturers, operators, and service providers:

- Verify the physical condition of the entire cylinders during annual lifeboat inspections.
 - Consider inspection methods that provide for visual inspection of all air cylinders **in their entirety** (e.g. fully accessing the storage compartment or using inspection cameras to view all cylinder surfaces while in their stowage location).

- Ensure air cylinder stowage compartments are maintained in a dry condition.
- Ensure that the air cylinders are inspected and maintained in accordance with [46 CFR 147.60](#), applicable to USCG approved lifeboats through [46 CFR 160.135-7\(b\)\(25\)](#).

- These cites invoke [49 CFR 180](#) that addresses corrosion and abraded areas, among other signs of defect or damage.
- Implement training for all personnel responsible for lifeboat maintenance or operation to provide awareness of the necessity for proper maintenance and inspection of lifeboat compressed air cylinders for all types of cylinder construction.

- Consider approved design changes that provide for routine access to all portions of the cylinders for proper inspection and maintenance.
- The Coast Guard also recommends that appropriate safety measures are implemented for any lifeboats that are not in active service (e.g. spare boats or boats removed from service for maintenance) or are part of an inspected vessel or unit that is no longer in active service. Safety measures could include, but are not limited to, bleeding pressure from the cylinders, removal of the cylinders from the lifeboat, or continuing regular inspection of the cylinders.
